Los Angeles County Metropolitan Transportation Authority

Panel Review of the Gold Line Eastside Extension

June 29, 2009 – July 2, 2009

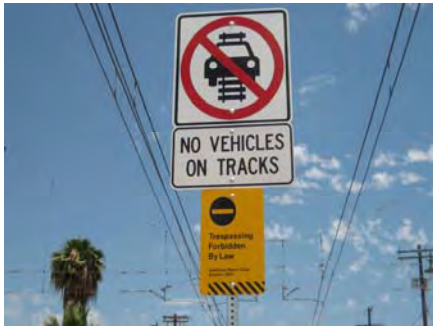
Figure 1 – No Trespass and No Vehicle Signs

Signs have been placed within the 1st Street and 3rd Street trainways to warn pedestrians of trespass and motorists that vehicles are not permitted on the tracks. These signs are appropriate. However, the No Trespass sign size and lettering appear to be too small. The team was not able to easily read the sign until they were in the trainway itself, defeating the purpose of the sign. On the other hand the “No Vehicle on Tracks” sign and “No Vehicles” symbol sign, appear to be appropriately sized. See Figure 1

There are several areas along 3rd Street where there are numerous “No Vehicle” signs in close proximity to one another. In other locations, such as Gless Avenue, the purpose of some of the signs is not clear and the number of signs confusing. Although the signs are meant to convey a clear message the frequency and clustering of the signs may add to driver distraction and confusion.

Recommendation 1 – No Trespass Signs

Evaluate the size of, and the lettering on, the “No Trespass” signs for readability and effectiveness. The signs should be able to be read before entering the trainway.

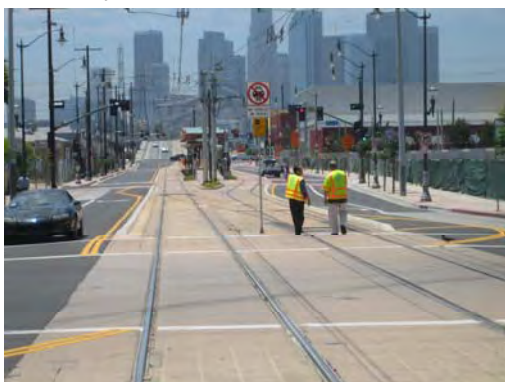
locations reflective paddles atop the curbs. The panel found the stamped concrete to be noticeable during daylight hours. During hours

of darkness, the color contrast of the stamped concrete area with the roadway was much less discernable. This is a concern as a motorist negotiating a turn may mistake the trainway for the roadway, and as a consequence, enter the trainway. Additional treatment is needed to more clearly indicate that the trainway is not a roadway and that motorists are not to enter it. See Figure 2.

Recommendation 4 – Trainway Delineation

At those locations where motor vehicles may mistakenly enter the trainway, as in Figure 2, place large raised buttons or rumble strips to tactilely indicate that the trainway is not a roadway. Additionally place reflective pavement markers along entry point to further highlight the area.

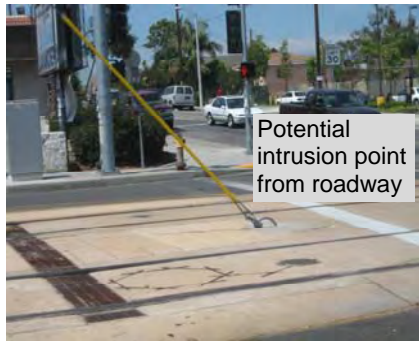
Figure 3 – Unprotected Guy Wire

At several locations, catenary poles and catenary guy wires are located at the intrusion entry point of the trainway. The poles and guy wires need to be protected from errant vehicles. An option is to protect the poles and guys with bollards striped with retro-reflective tape. See Figure 3.

Recommendation 3 – Catenary Pole/Guy Wire Protection

Place bollards or other devices to protect the catenary poles and guy wires from being accidentally struck and damaged by an errant motor vehicle.

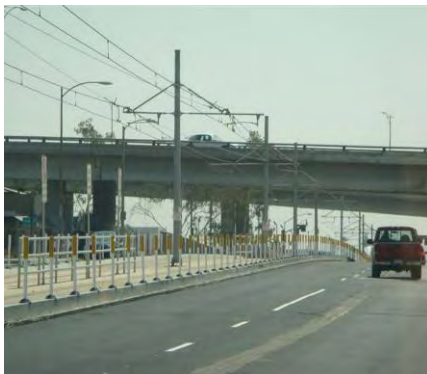
Figure 4 – Reflective Paddle Delineators

The reflective paddles along 3rd Street visibly outline the trainway. However, the paddles are likely to become a maintenance issue as they are easily damaged. Several damaged paddles were seen during site visits. There are several other treatments that can achieve the same effect. One option is to place yellow raised buttons on the curbs with reflective pavement markers place every third one or so. Another option is to simply place reflective pavement markers on the curb. If on the other hand paddles are to be retained, they should be placed at approximately 15-foot intervals.

Recommendation 5 – Trainway Delineators

Consider using raised button and/or reflective pavement markers, in lieu of reflective paddles, to outline the trainway.

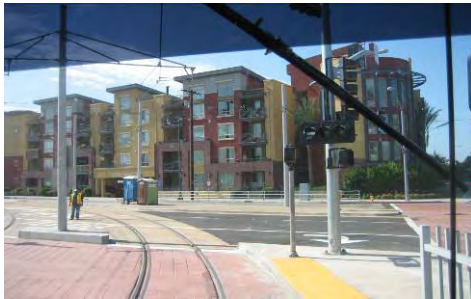
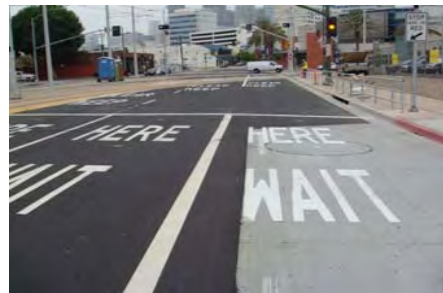
Eastbound train moves from Little Tokyo Station through 1st Street and Alameda Avenue require operators to negotiate the move at 10 mph due to the sharp curve.

Trains moving through this crossing frequently encounter motor vehicles encroaching in the designated “Clear Zone”. The encroachment may be due to motorist confusion as to where to stop, as the “Wait Here” and “Keep Clear” zones appear to blend together. The encroachment creates two problems. First, it may impede train movements. Second, a train moving through the crossing may collide with the stopped vehicle, as it may not always be evident to the operator that there is insufficient clearance. The use of markers to define the dynamic envelope will assist the operator in knowing whether it is safe to proceed through the curve. Train clearance markers have an added benefit. They provide a visual queue to the operator where the end of the train is in relation to the curve and when it is safe to accelerate.

Recommendation 11 – Dynamic Envelope Delineation

Mark the dynamic envelope of the train through the curve. This may be accomplished with striping or other treatment.

Recommendation 12 – Stop Bar Enhancement

Enhance the stop bar to make it more evident where motor vehicles are to stop.

Recommendation 13 – “Keep Clear” Zone

Cross hatch the “Keep Clear” zone to make evident that motorists are not to enter the zone.

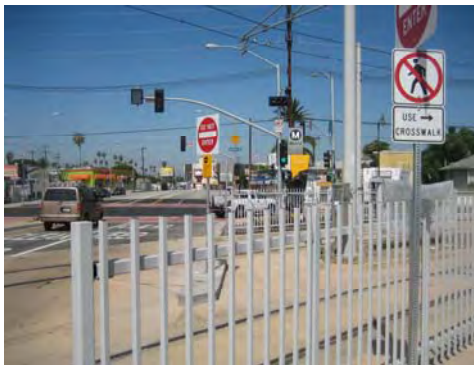
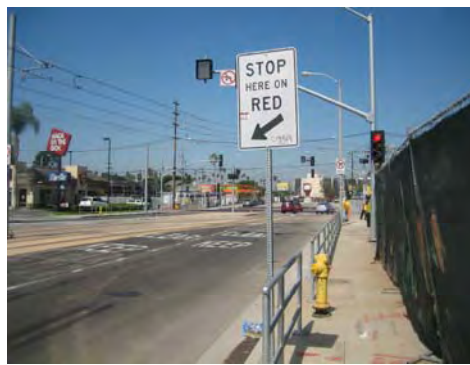
The photographs above show a view on 3rd street looking west at Indiana Avenue. The light rail station is just to the right in each photograph. Pedestrians approaching Indiana Avenue from the west (northwest quadrant of the intersection) are directed across

Indiana (toward the northeast quadrant) and onto what appears to be a pedestrian island. The area is not a pedestrian island, but in fact the northeast corner of the intersection. After reaching the corner, pedestrians are to proceed to the pedestrian crossing located on the south end of the 3rd and Indiana Station, if they wish to continue east along 3rd Street. Pedestrians are not to continue across the tracks as it places them into the roadway with no safe refuge, such as a sidewalk.

To discourage pedestrians from proceeding straight, there are picket fences on both the east and west sides of the trackway. However, the fencing on the east does not fully extend to the curb line, not making it fully clear that pedestrians are not to proceed straight across. Pedestrians ignore the fencing. The panel witnessed this several times during the site visit. Additional means are needed to direct pedestrians to the station crossing and to discourage them from proceeding straight. This is not an issue from the east approach to Indiana Avenue, as a pipe rail fence (right photograph) effectively directs pedestrians to the station crossing. Consideration should be given to extending the fence on the island to further discourage pedestrians from continuing on their original path.

Recommendation 23 – Pedestrian Island

Consideration should be given to extending the picket fence on the island to discourage pedestrians from continuing straight across the light rail tracks. A sign stating that pedestrian are prohibited from crossing the tracks at this location should be placed on the fence, as well.

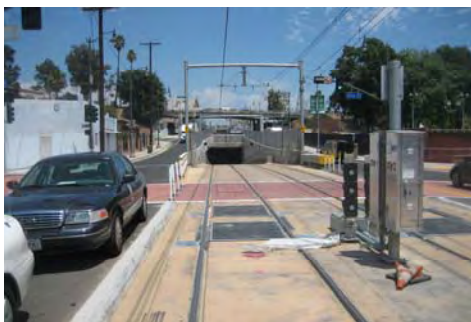
1st Street and Gless Avenue is the locality of the west end of the tunnel. Prior to the construction of the tunnel portal, vehicular traffic was permitted to cross 1st Street at this location. Now, high curbs with large reflective paddles on top have been put in place as a crossing barrier. A number of active and passive signs were also in place, informing motorists that they must not turn and proceed straight ahead. Although no damage to the barrier was found, the signage at this location

was cluttered and may be confusing. There were “No U Turn” and “No Left Turn” signs on Gless Street (only right turns are permitted). Signage at this location should be evaluated.

Recommendation 24 – Reevaluate Signage

Reevaluate the signage on Gless Avenue, as many of the signs are no longer applicable.

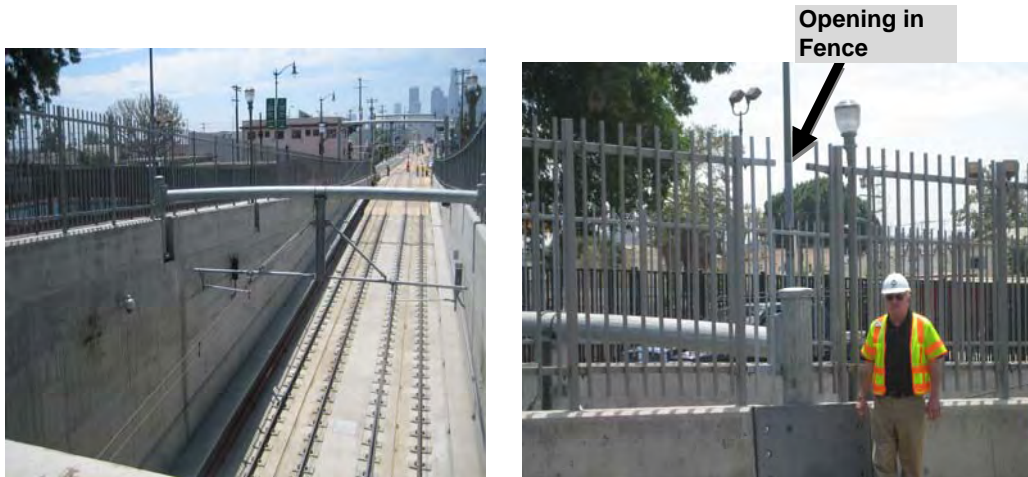
A significant safety issue was identified at the west portal (above photographs). The pickets on the perimeter of the portal walls are spaced far enough apart to permit objects from being pushed through and landing on the trainway, making contact with the catenary, or being dropped in front of an approaching train. Additionally, there is a large opening (see photograph on the right) that allows a person to climb on to the pipe spanning the tracks. Tight wire mesh or other tightly woven fabric should be placed on the pickets to prevent objects from being pushed through. Additionally, the large openings on each side of the pipe span should be closed.

Recommendation 25 – Picket Fence

Place tight woven fabric or mesh on the inside of the picket fence to prevent objects from being pushed through.

Recommendation 26 – Picket Fence Opening

Close the large opening on each side of the pipe span to prevent individuals from climbing onto the pipe.

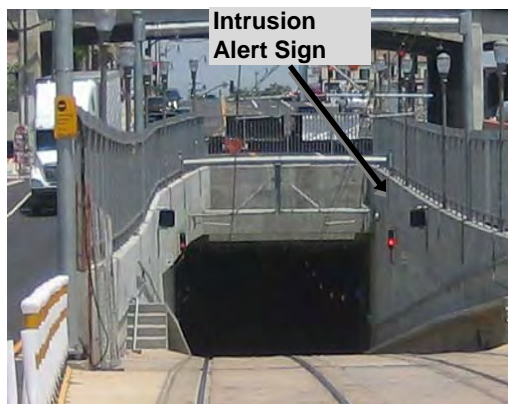
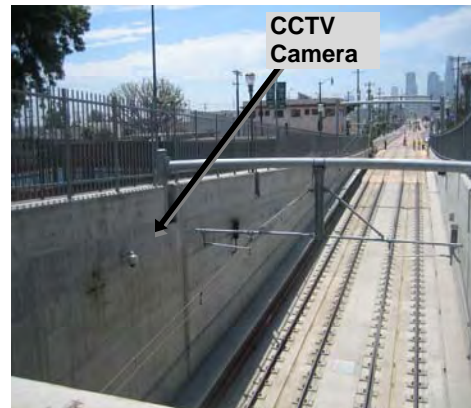
At each underground station there is an intrusion detection system that will be coupled to the platform end gates. Intruders entering the tunnel through the gate are immediately detected; sending an alarm to the ROC and are viewed through a CCTV system. Intrusions by stepping off the platform and into the trainway; however, would go undetected, as the detection device is only on the gate. Moreover, the platform detection system and the portal detection system are not integrated. Consequently, an intrusion from the portal would not automatically and immediately alert train operators already in the bores (the ROC Controller would have to notify these operators of the intrusion via radio communications). Conversely, trains entering the tunnel would not know of an intrusion from one of the stations unless notified by the Controller. Similarly, a train that has passed any one of the visual alerts would not know of an intrusion. For example, an eastbound train leaving the Boyle Heights Station would not know of an intrusion from the east portal. For safety and security reasons, it is vitally important that all trains be immediately informed of an intrusion. All of the detection systems should be fully integrated; sending visual alerts to all signs. Furthermore, an audible and visual alert should be annunciated locally to inform the intruder that they have been detected and they are to leave immediately.

Recommendation 32 – Detection System Integration

Integrate the platform and portal intrusion systems so that detection at any location will send an alert to all locations.
