**Draft Facilities
Master Plan
August 26, 2008**

DRAFT FACILITIES MASTER PLAN TABLE OF CONTENTS

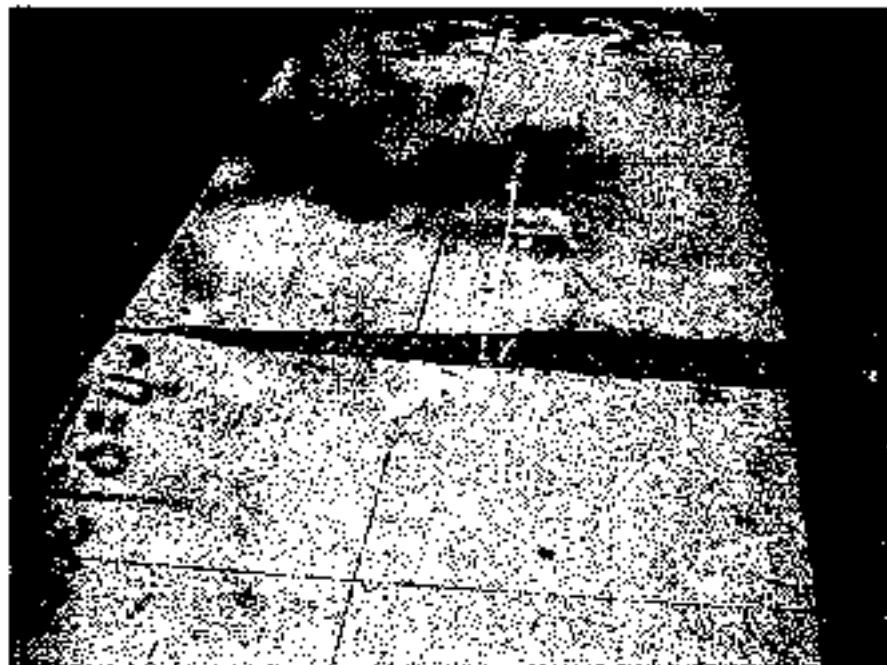
Perimeter sidewalk has areas requiring repair. These areas are trip hazards.

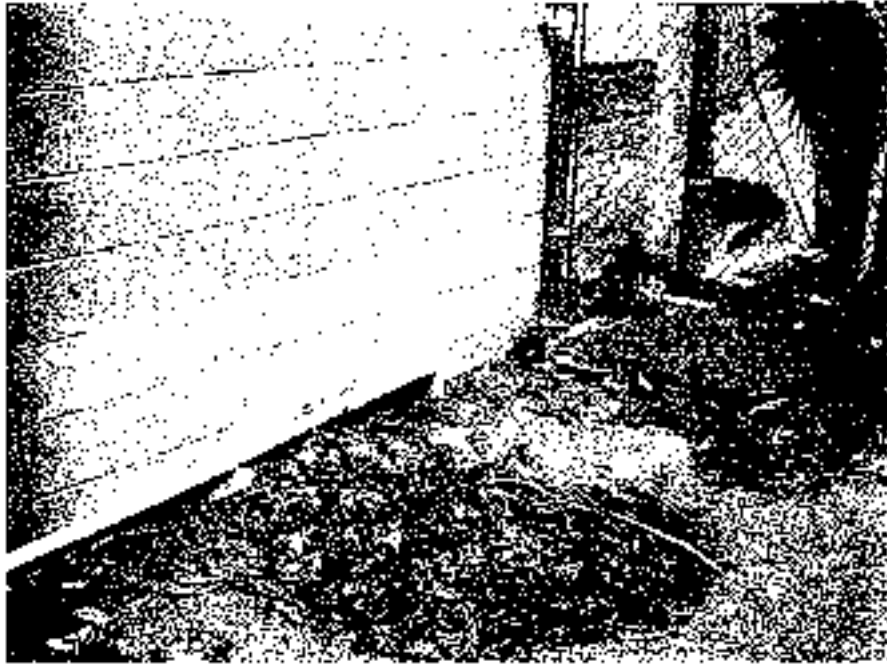
Drainage swales in Faculty Parking Lot require maintenance.

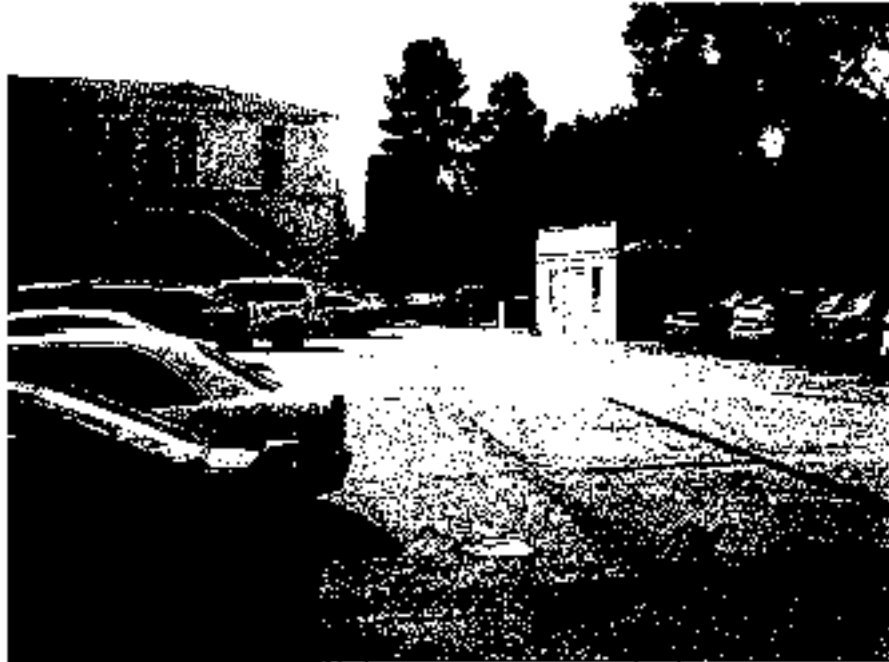
Faculty Parking Lot is in poor condition. Removal and replacement of majority is necessary.

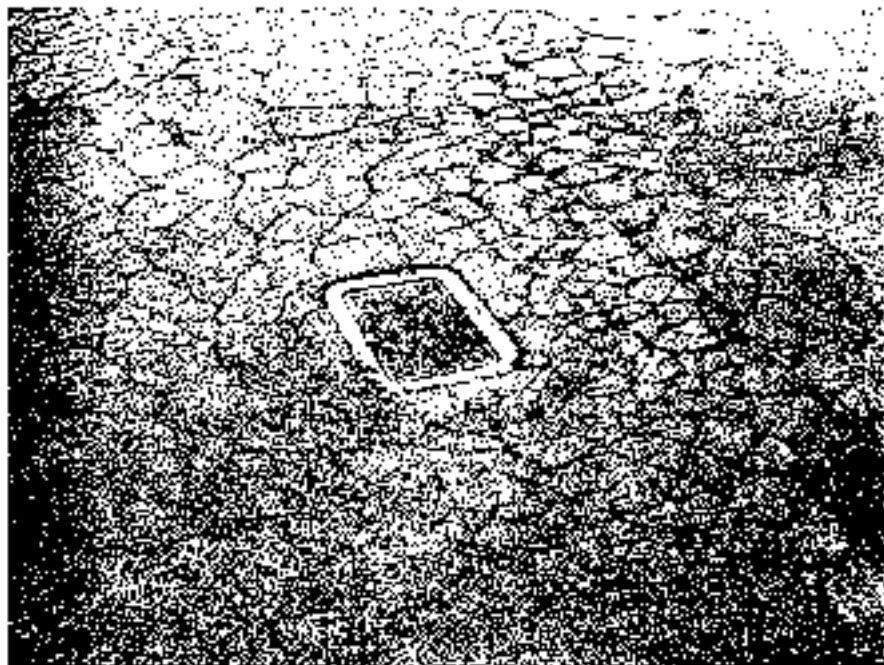
Faculty Parking Lot is in poor condition. Removal and replacement of majority is necessary.

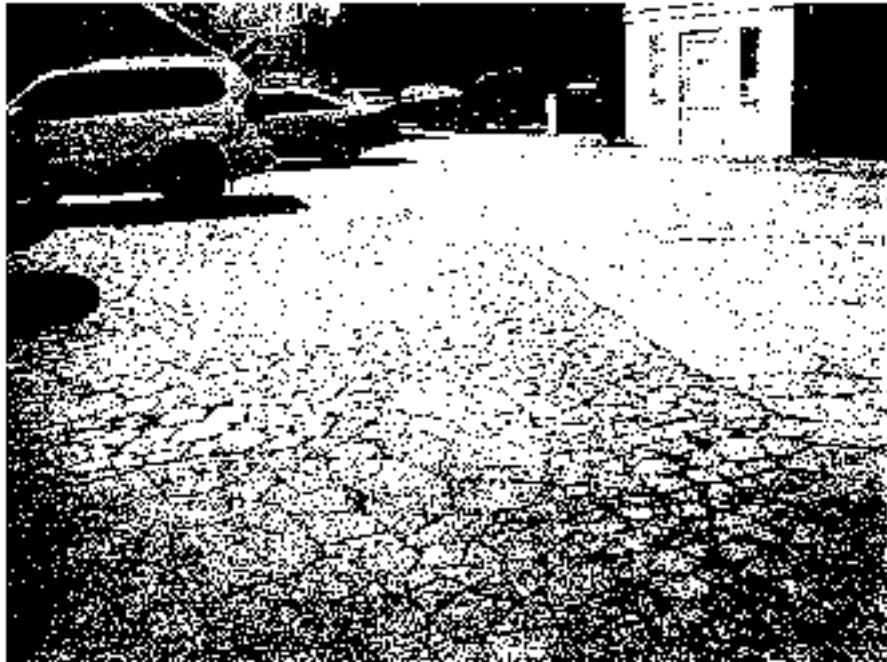
Faculty Parking Lot is in poor condition. Removal and replacement of majority is necessary.

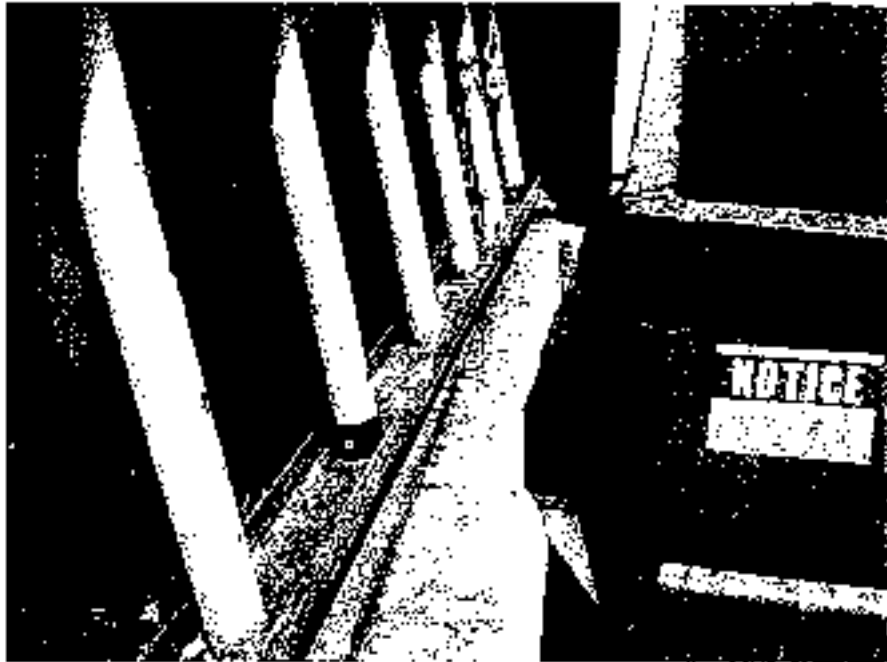
Retaining wall behind trash bins requires repair.

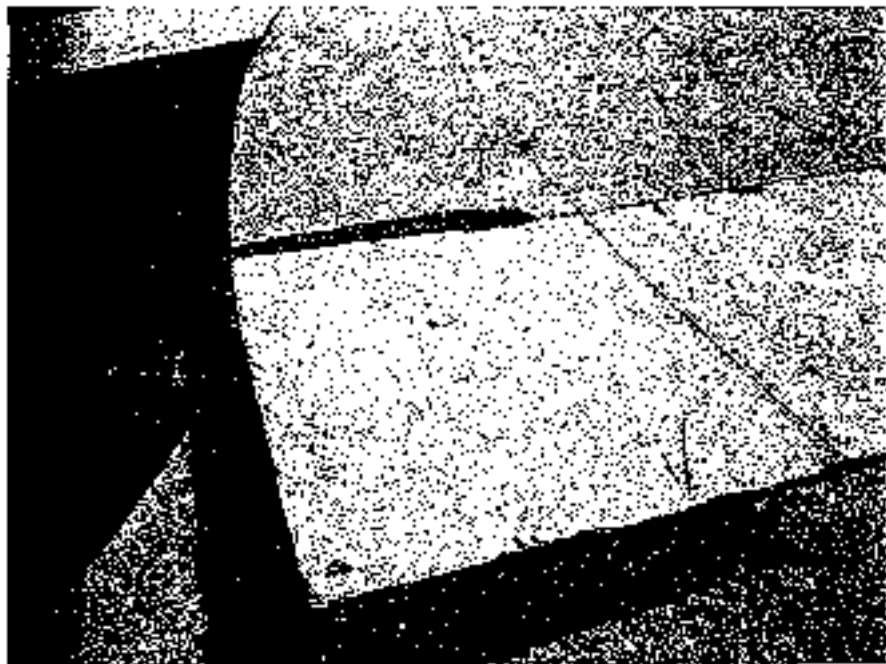
Concrete walkway at school entrance requires repair.

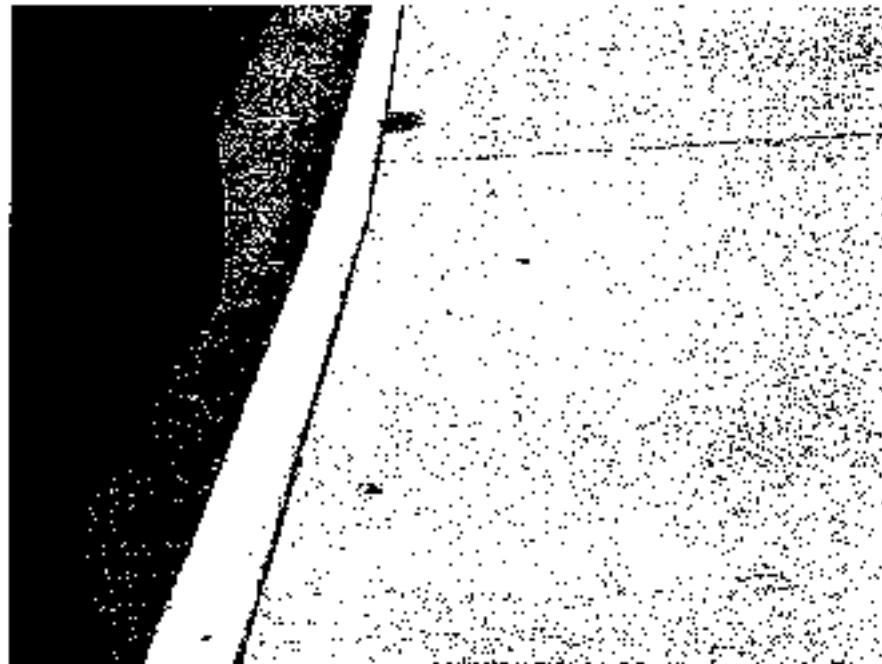
Perimeter sidewalk requires repair in many locations – there are trip hazards.

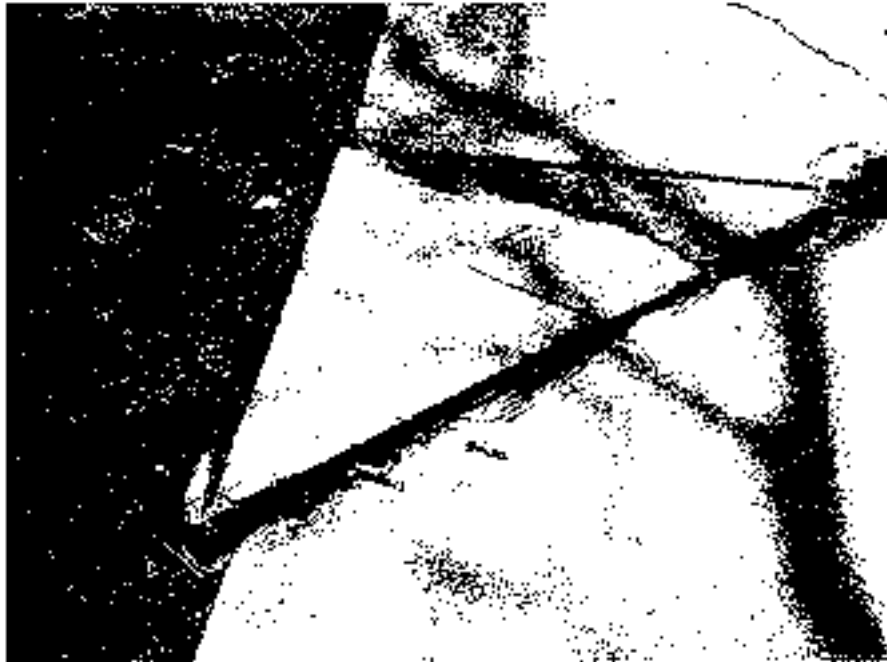
Perimeter sidewalk requires repair in many locations – there are trip hazards.

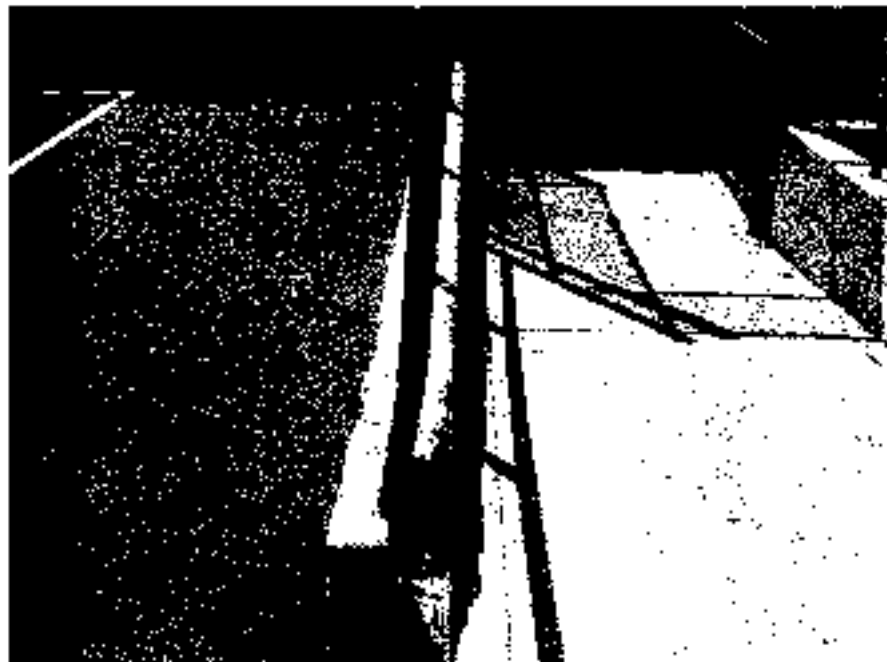
Play area handrail requires repair.

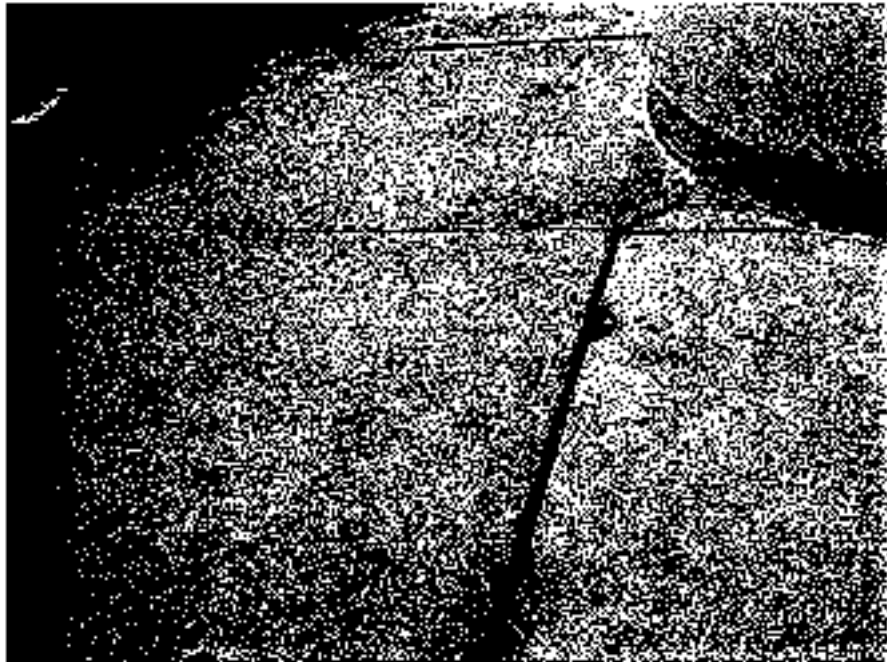
Concrete walkways in south campus garden area require repair.

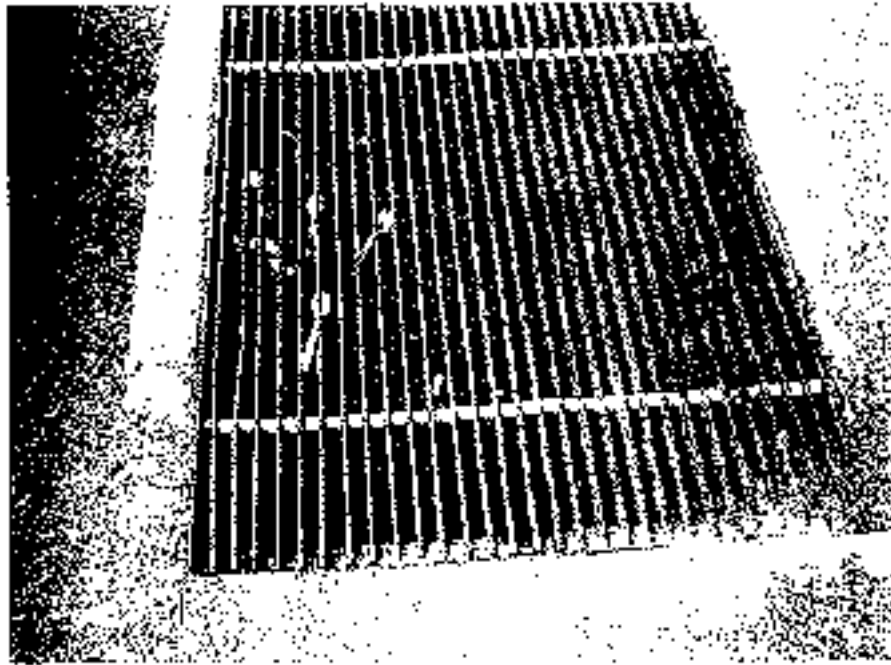
Many surface drains are plugged with debris require maintenance prior to next rainy season.

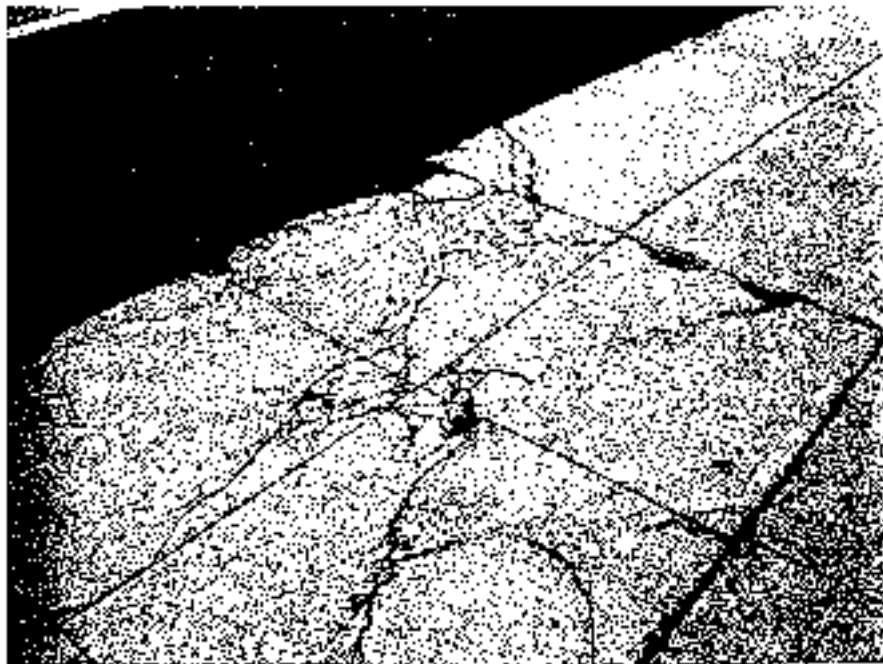
Perimeter sidewalks require repair.

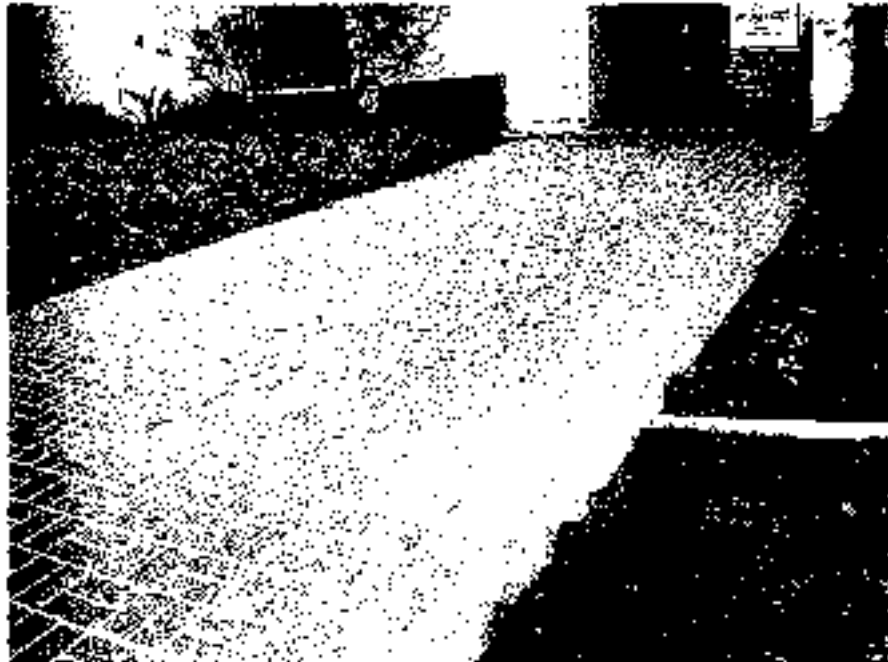
Brick pavers near flagpole are in poor condition. Repair or replacement is required.

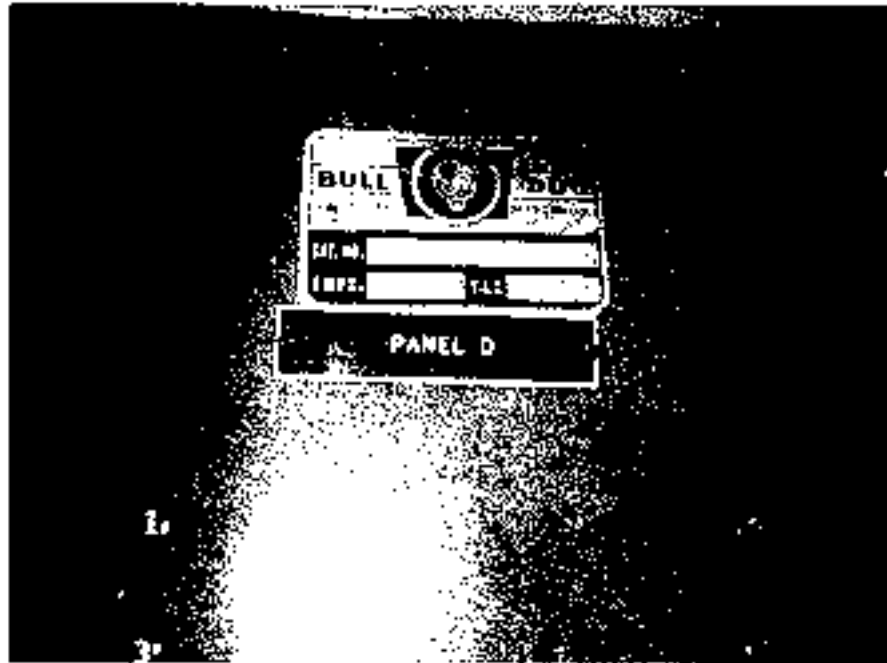
Replace old Bulldog Panels in Second Floor Corridors (E-11A)

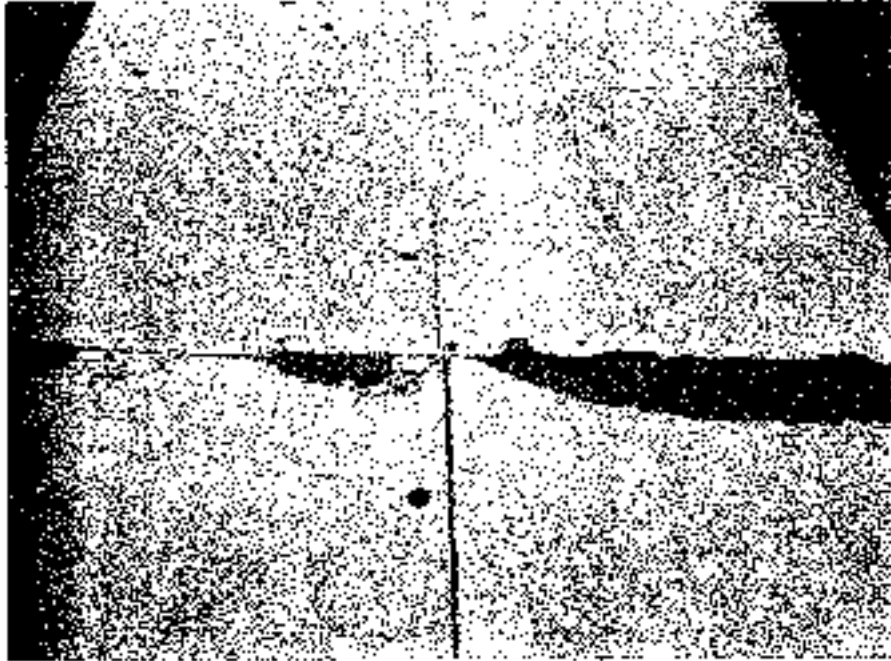
Perimeter sidewalk is in fair condition. Some repairs are required.

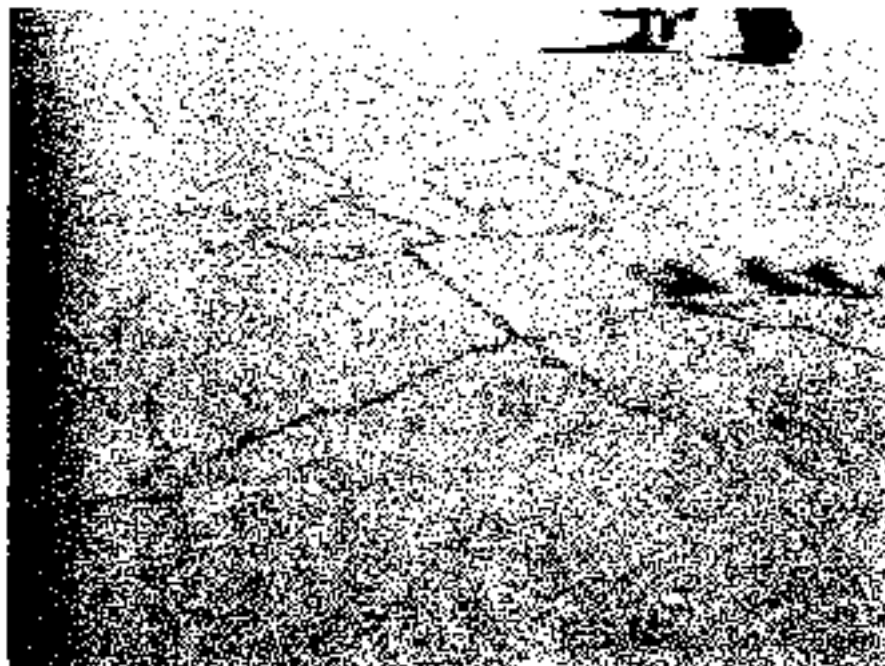
Asphalt playground is in fair to good condition. Crack/slurry seal is needed within 5 to 10 years.

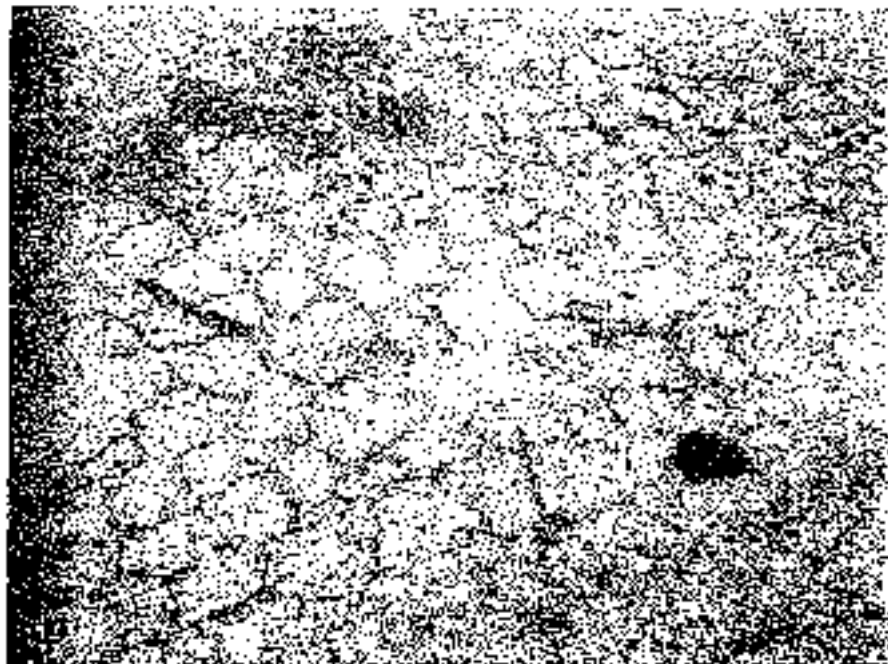
Main road through campus is in fair shape. Some repair and crack/slurry seal is required.

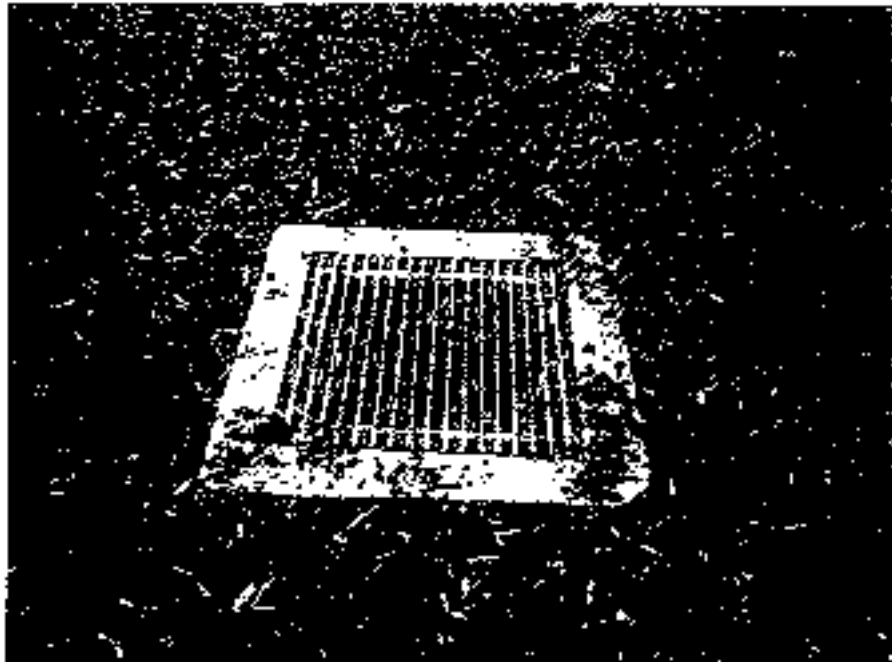
Many surface drains are plugged with debris and require maintenance prior to next rainy season.

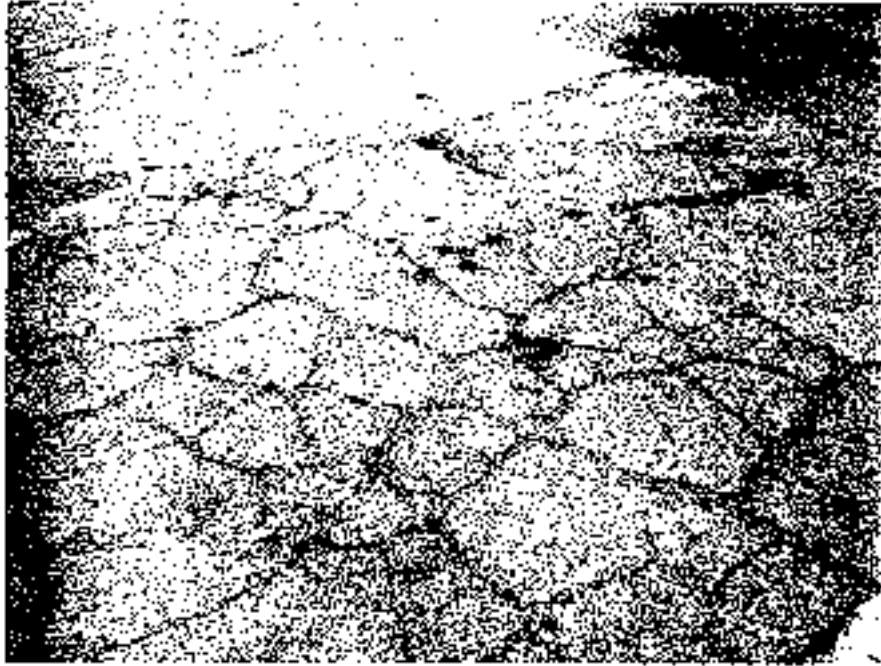
The parking lot north of the Swim Gym and is in poor condition. Removal and reconstruction is required.

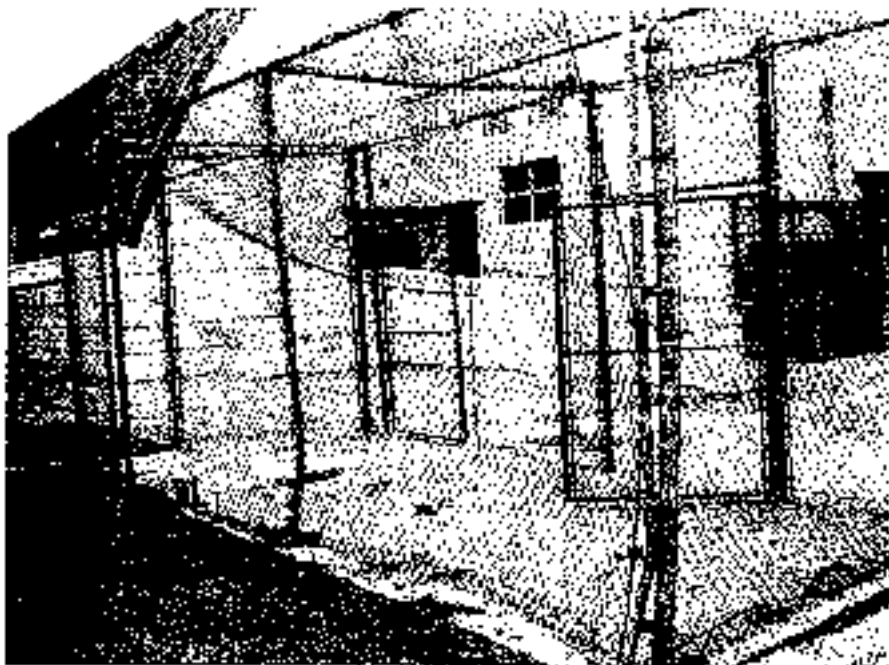
The abandoned electrical compound should be removed.

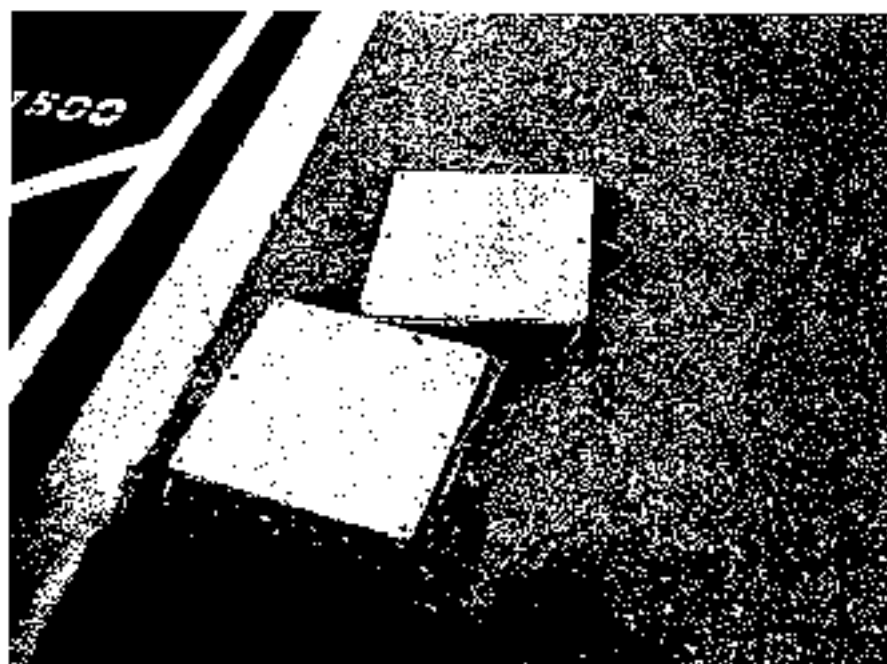
Handholes next to track require repair.

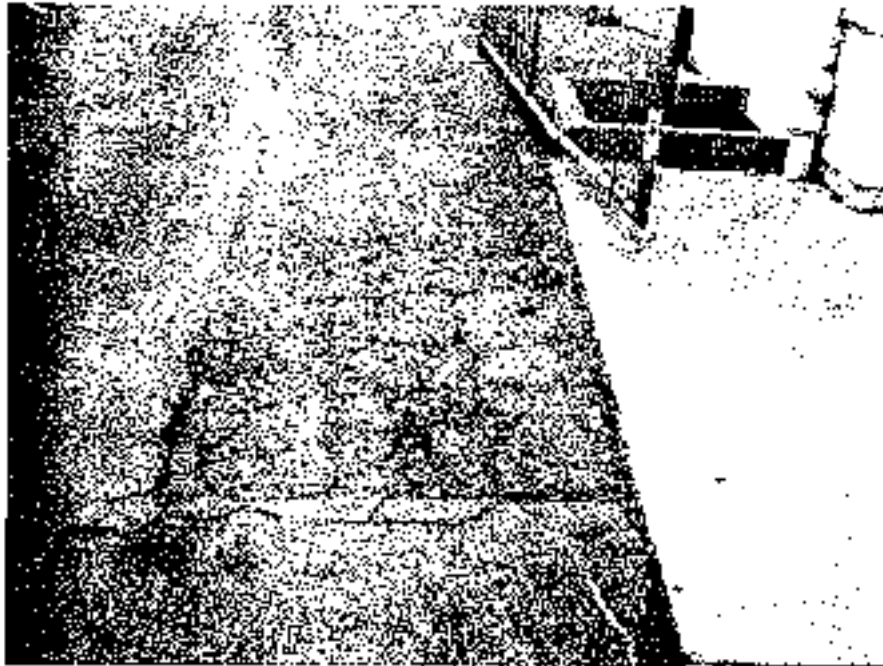
The concrete and asphalt around the weight room is in poor condition. Remove and replace poor concrete and crack/slurry seal asphalt.

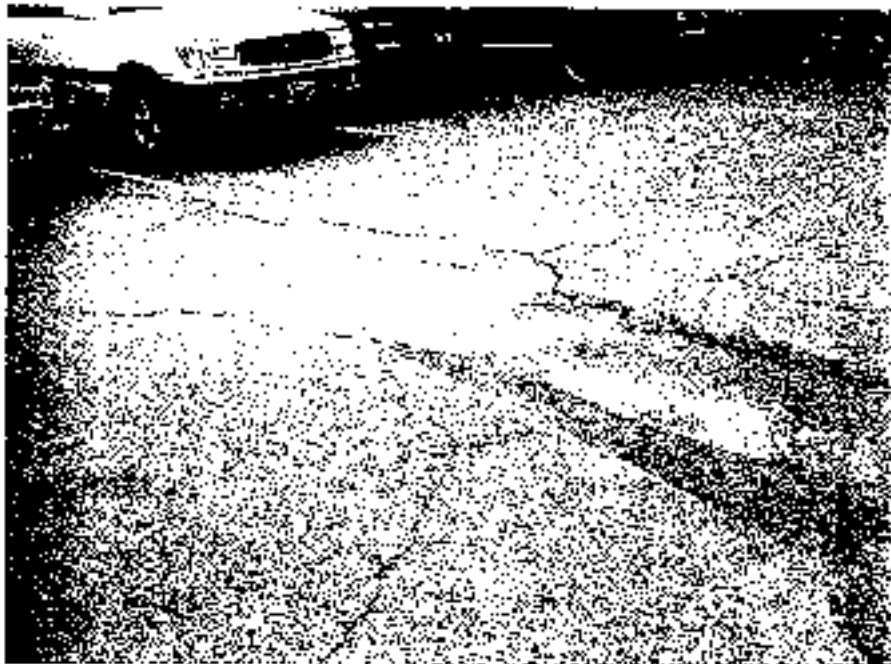
The upper parking lot and upper perimeter road require crack/slurry seal.

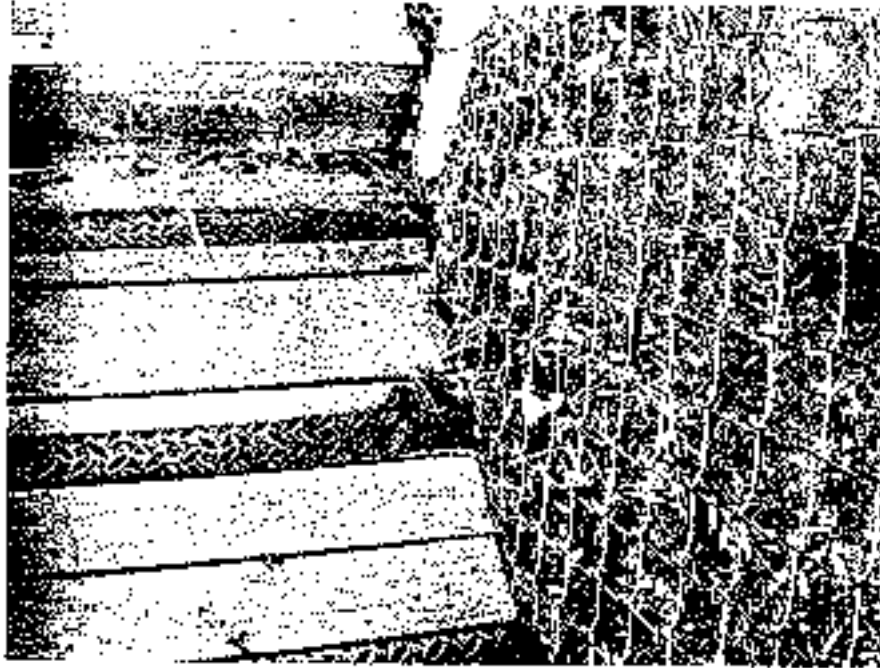
The wood stairs from the softball field to the upper campus require repair. Reconstruction with concrete stairs within 5 years is recommended.

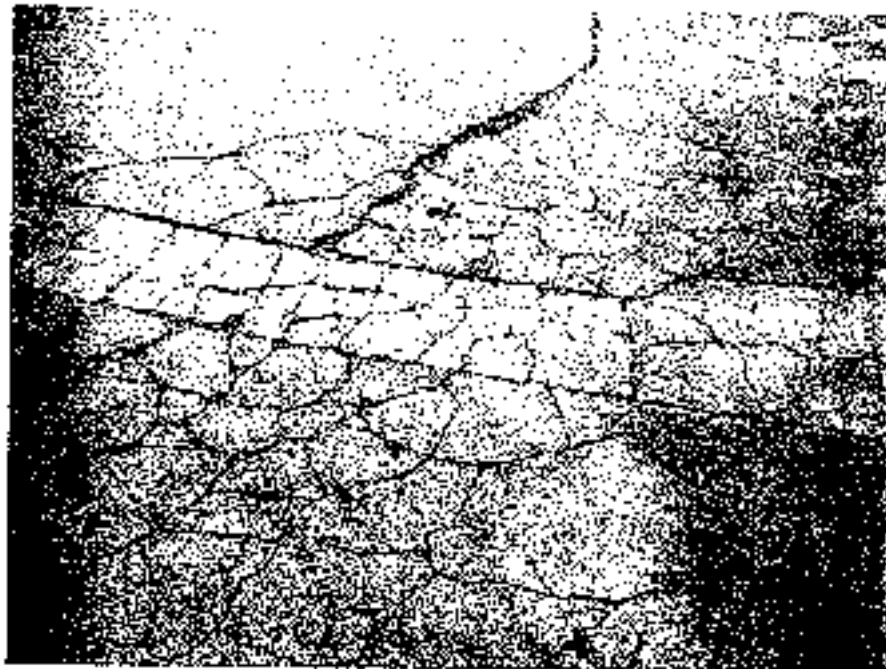
Parking lot requires removal and replacement.

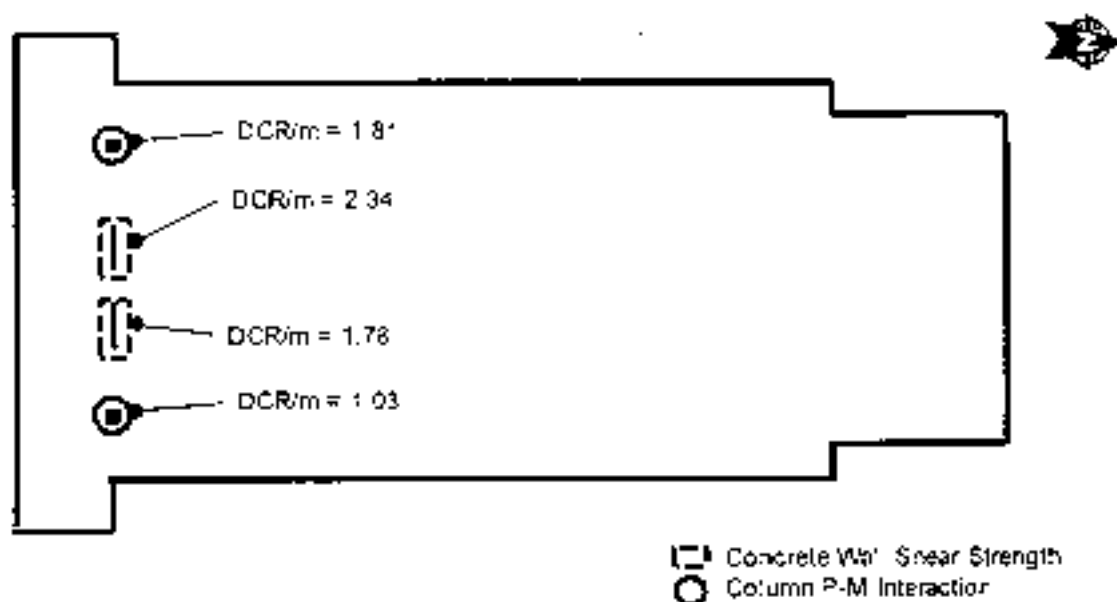
Figure 12: Building B (Auditorium), Strength Deficiencies of Second Floor Walls

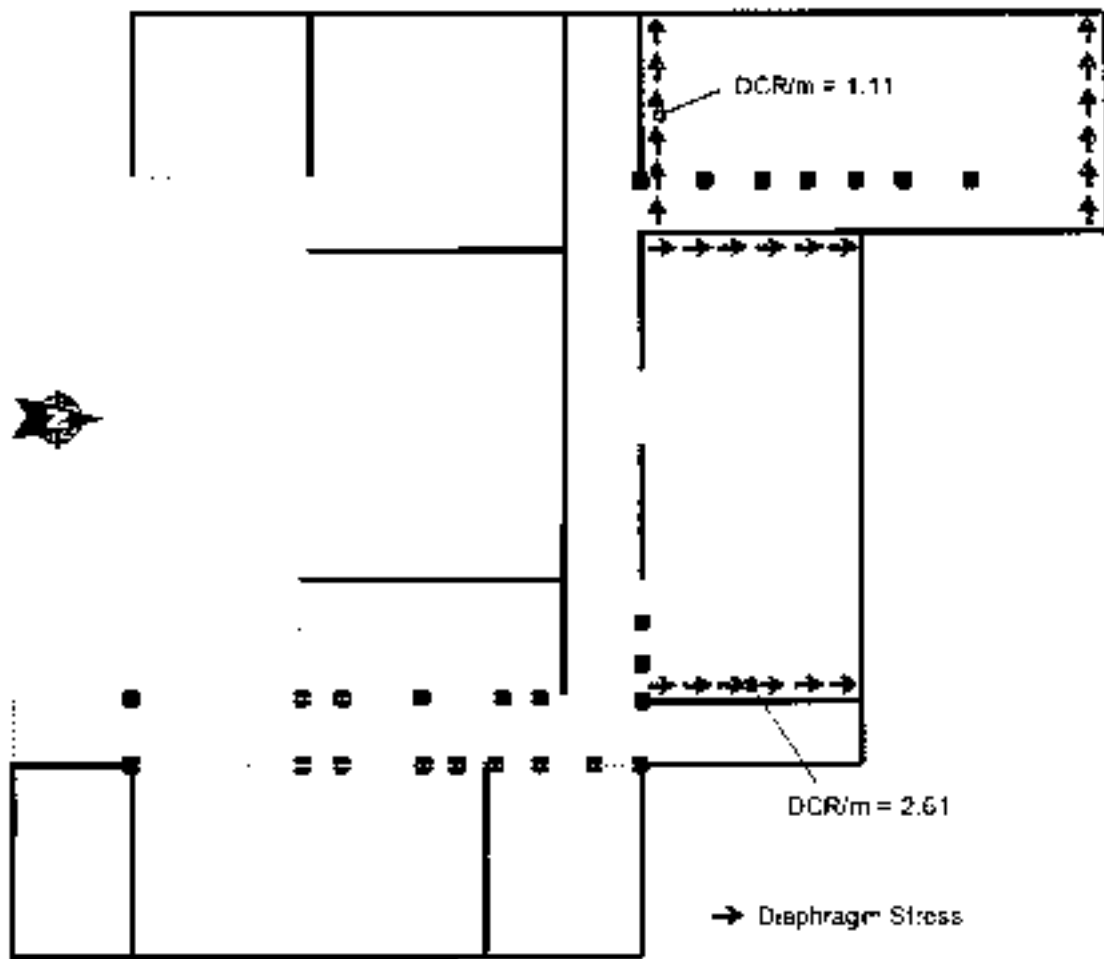
Figure 15: Building B (Art & Music), Structural Deficiencies at 2nd Floor Diaphragm
