SEISMIC CONE PENETRATION TEST RESULTS - C-128
Wilshire Blvd.
MACTEC

**FIGURES A-5.1 THROUGH A-5.3
DMT PLOTS (PE PHASE)**

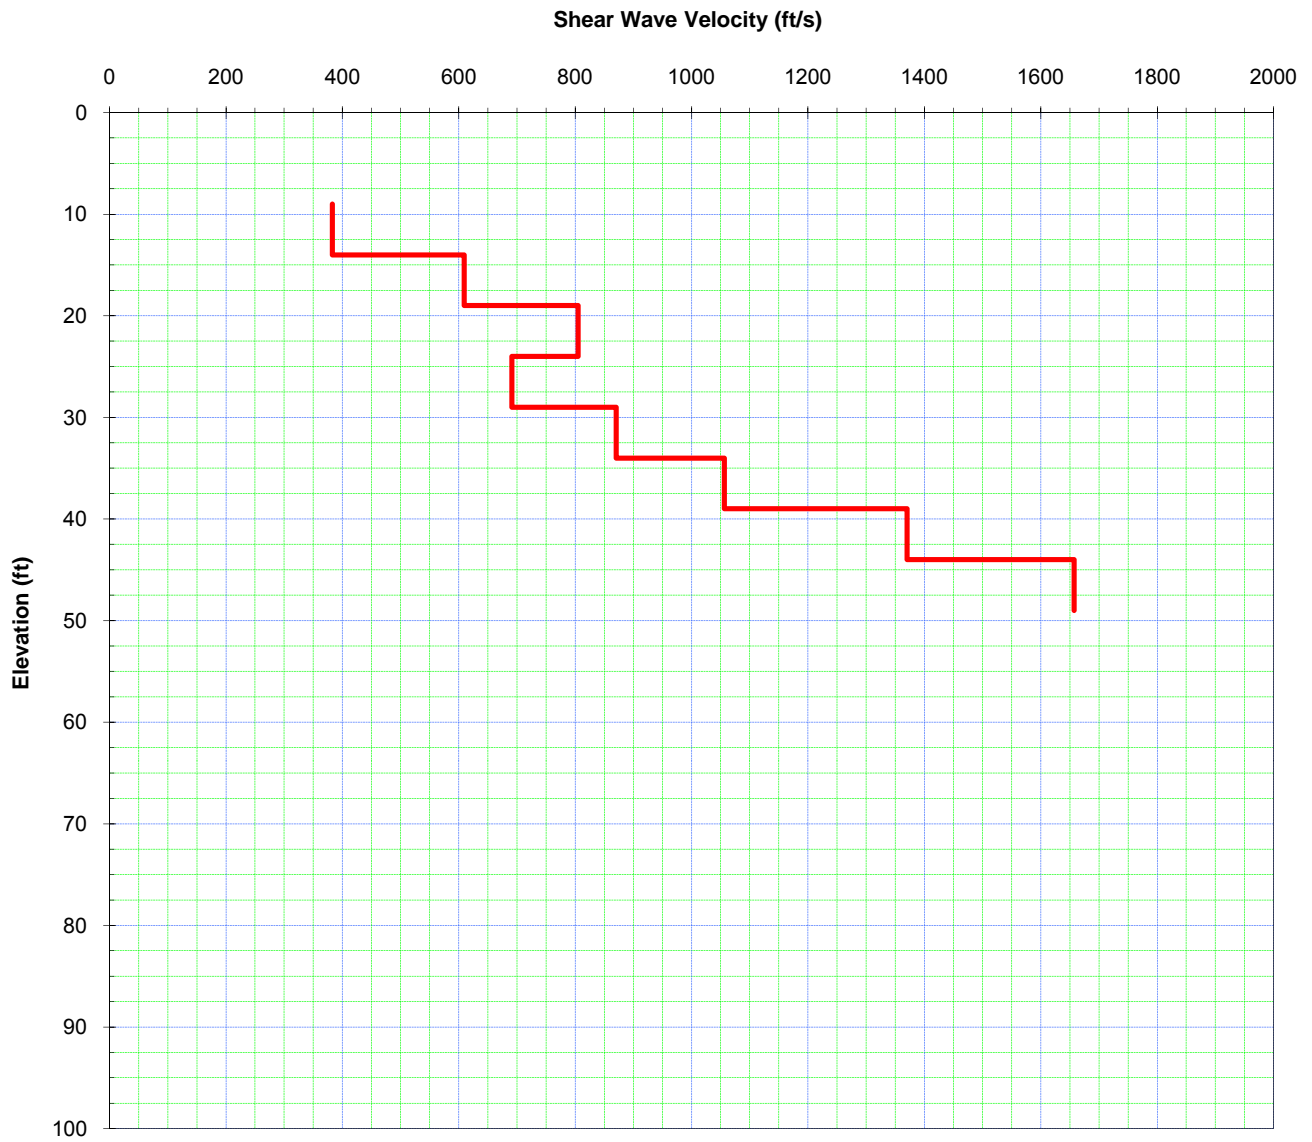
Figure A-4.65

SEISMIC CONE PENETRATION TEST RESULTS - CB-104
Wilshire Blvd.
MACTEC

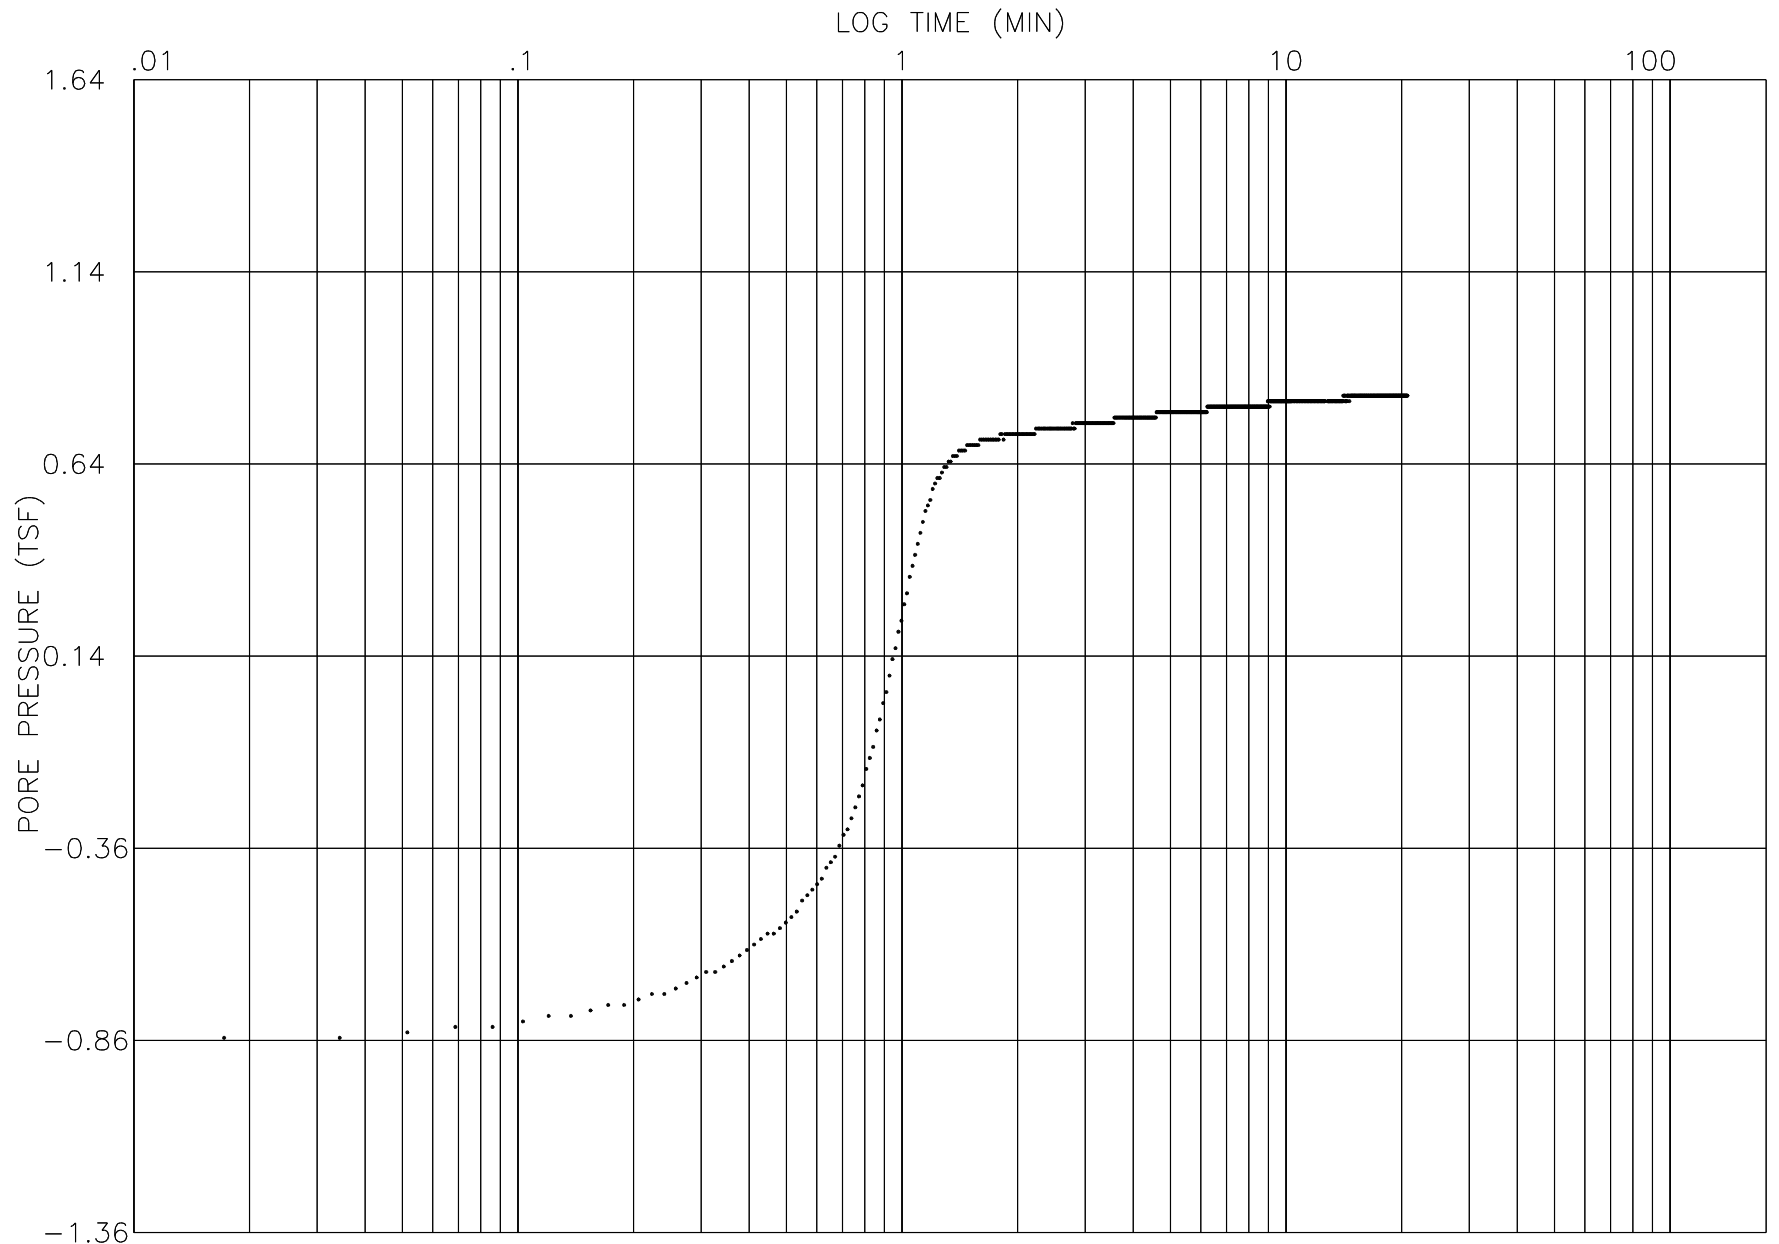
Figure A-4.94

CPT NUMBER: CB-101
 JOB NUMBER: 04.0911-0016

DISSIPATION TEST

DEPTH: 41.57 Feet
 DATE: 06-Jun-2011

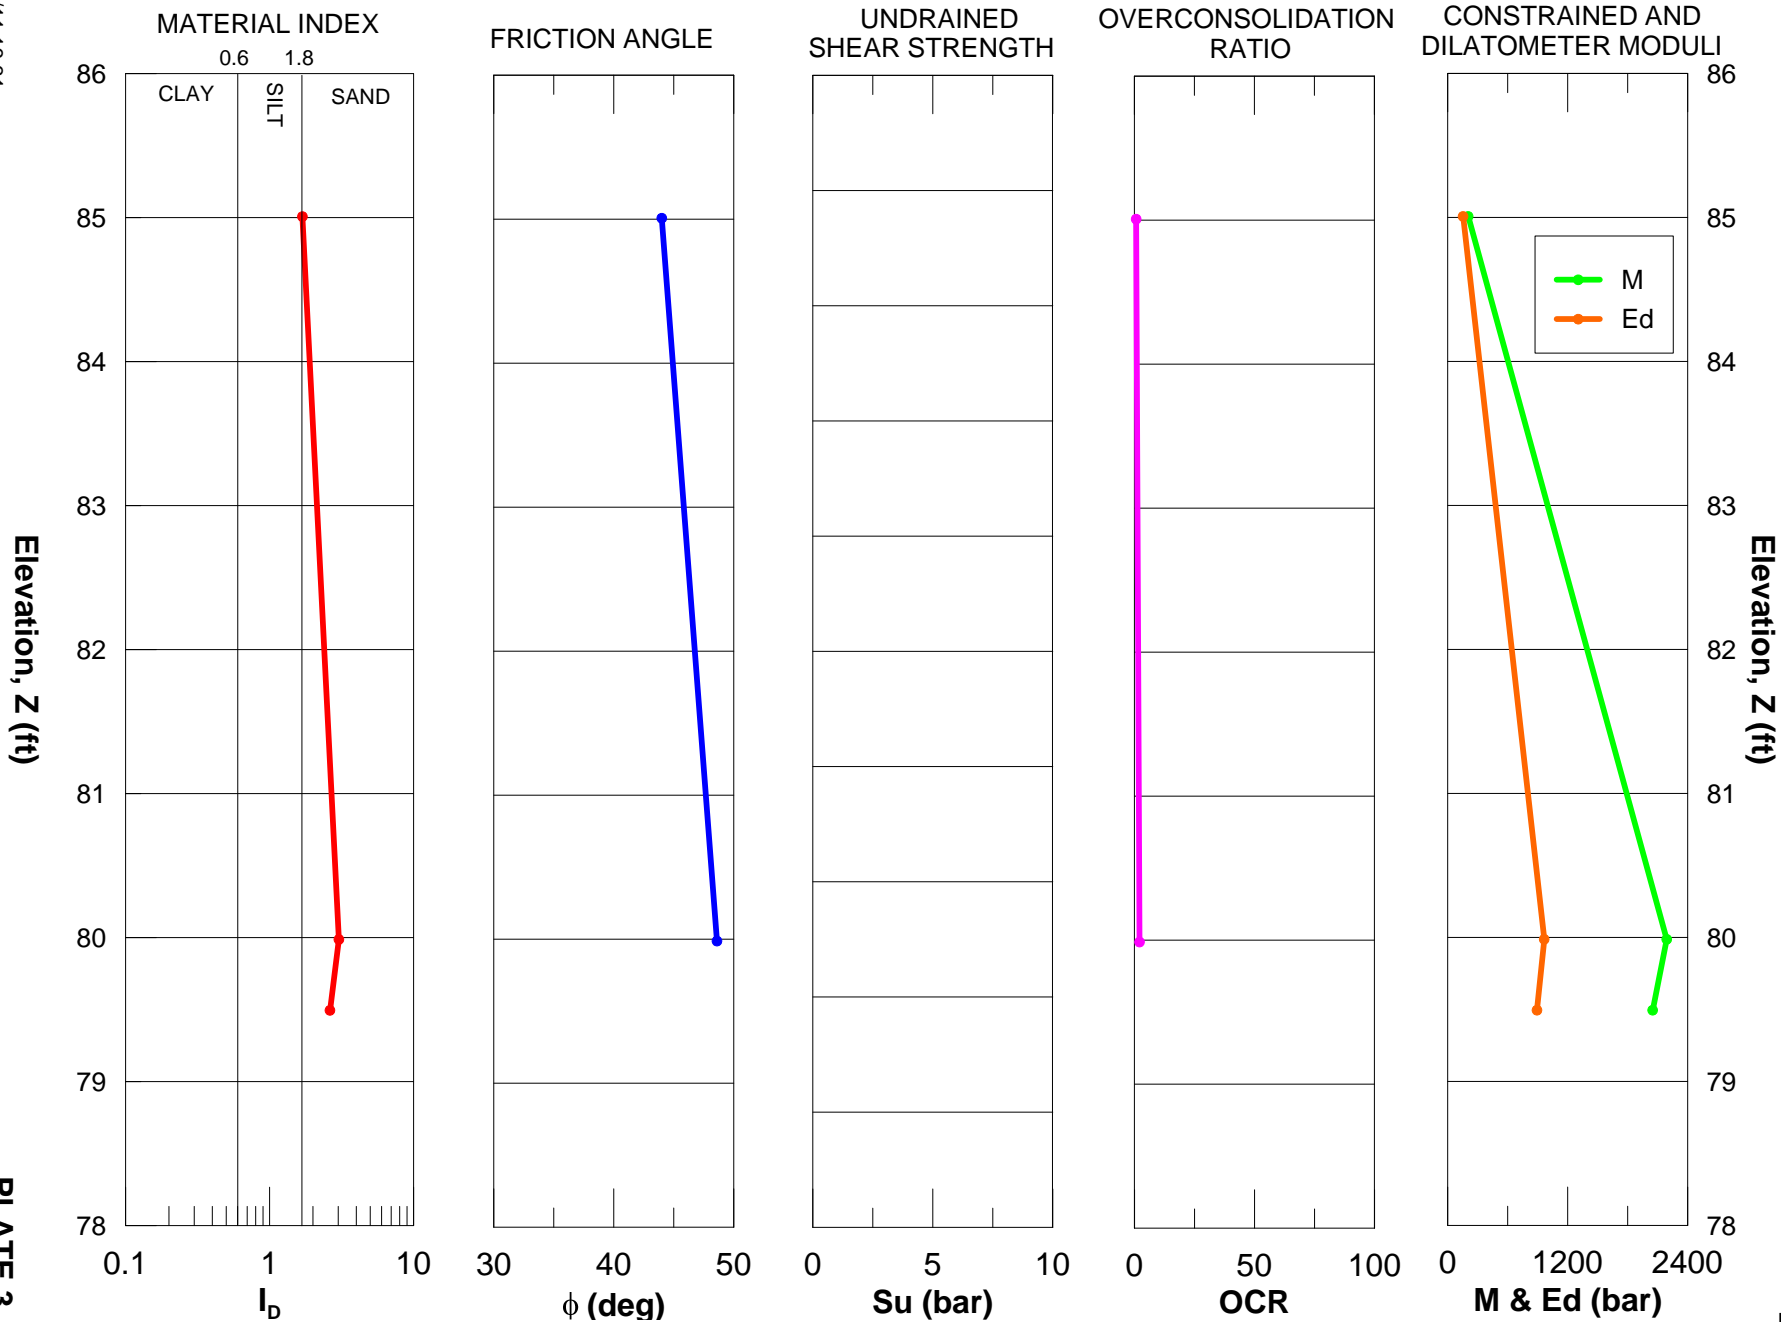
FIGURE A-5.2

DILATOMETER RESULTS

Sounding: DMT-3 Location: C-124 Sounding Date: 06/04/2011 Nominal Elevation: 100 ft
