WESTSIDE EXTENSION TRANSIT CORRIDOR STUDY

Project No. PS-4350-2000

Task 13 Final Metro Red Line Vibration Study (10d and 10g) (REV 1-April 2011)

Metro Red Line Vibration Study dated May 2009 (Preface – April 2011)

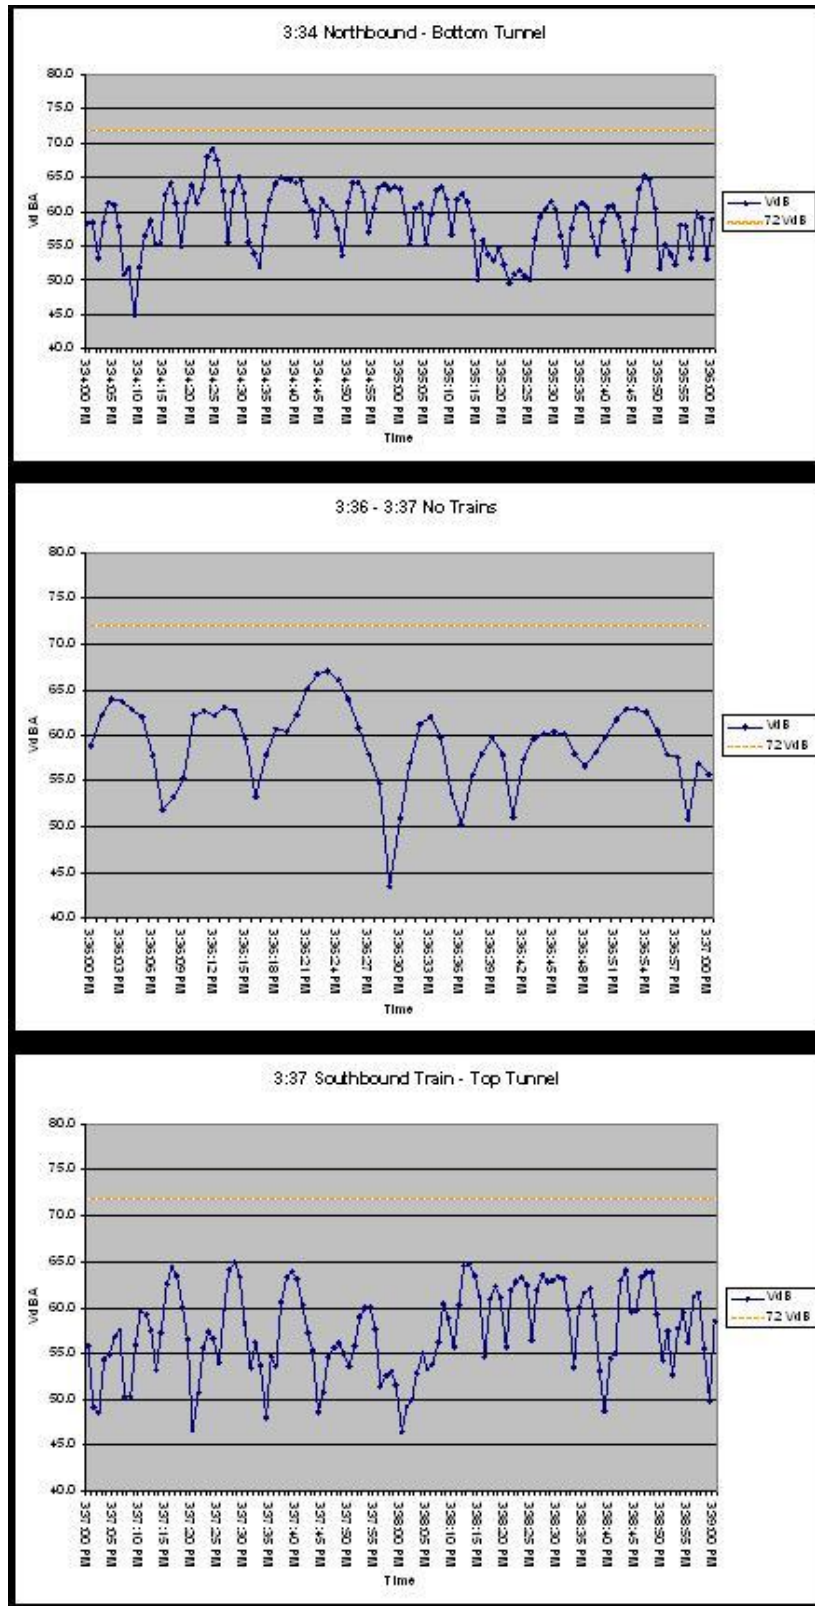
Figure 4. Observed Vibration Levels (New Hampshire Avenue and West 5th)

Figure 4 (Figure V-1B from Appendix C: Southeast corner of New Hampshire Avenue and West 5th Street) is also presented below to illustrate the variation in vibration level with time during two typical periods with train activity (top and bottom graphs) compared to a no-trains period (middle graph) and to the FTA impact criterion of 72 VdB. The graph indicates vibration levels in increments of five VdB. Note that the measured vibration levels are very similar and all are below 72 VdB for this location.

The representative vibration time-history data plots (1-second rms velocity level in VdB versus time) for each of the measurement locations are shown on Figures V-1A through V-5E contained in Appendix C.

Importantly, the results of measurements conducted during subway train activity, as summarized in Table 1 and presented on Figures V-1A through V-5E (Appendix C), are below the FTA vibration impact criterion in residential areas. The results of the measurements performed during periods of subway train activity were similar to those during no-train periods. A brief discussion of the FTA impact criteria follows.

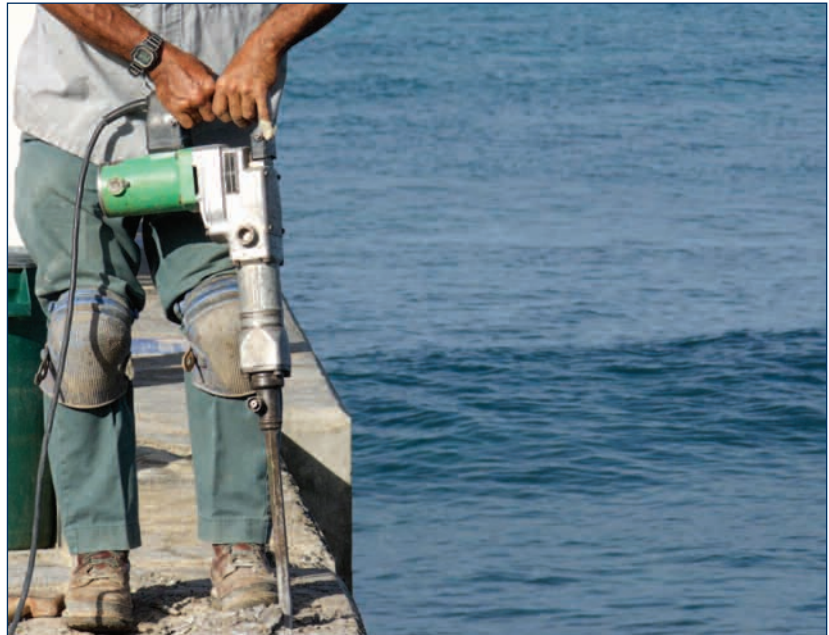
HVM100 is ideal for hand-arm and whole-body exposure assessments

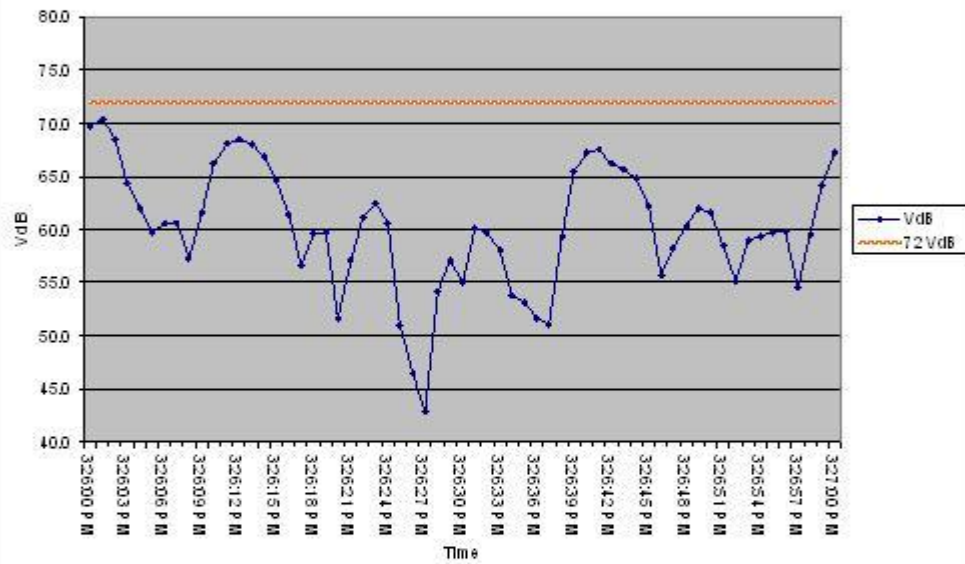
3:26 - 3:27 No Trains

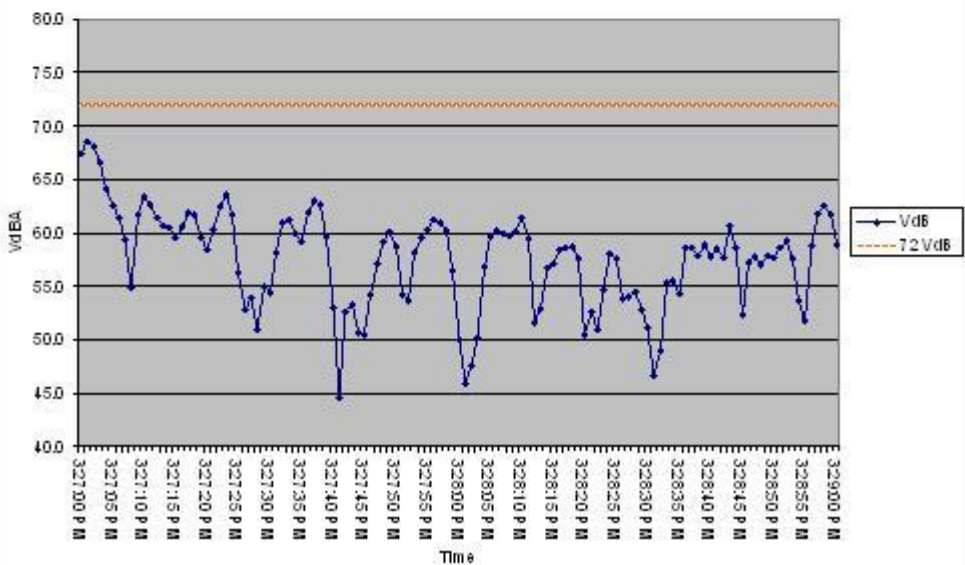
3:27 Southbound Train - Top Tunnel

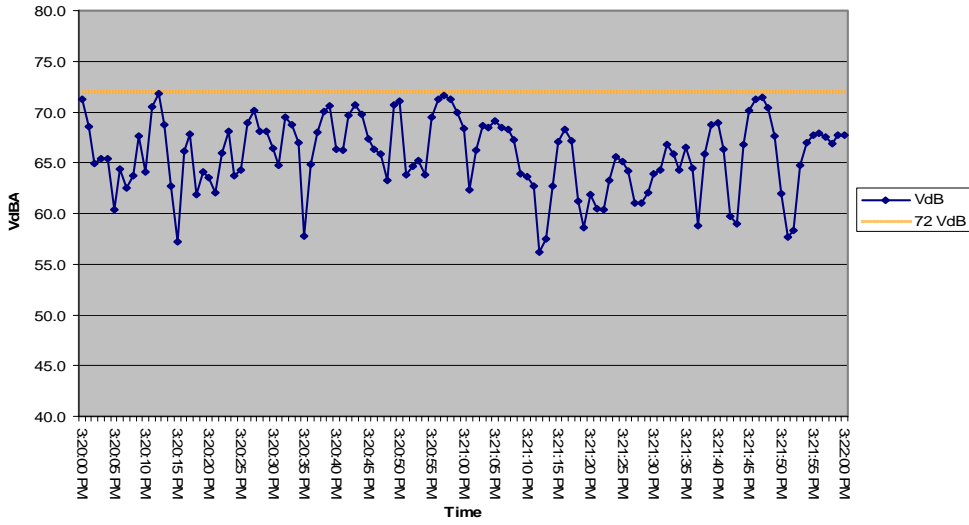
**3:20 Northbound Train Leaves Universal City
Arrives North Hollywood 3:22**

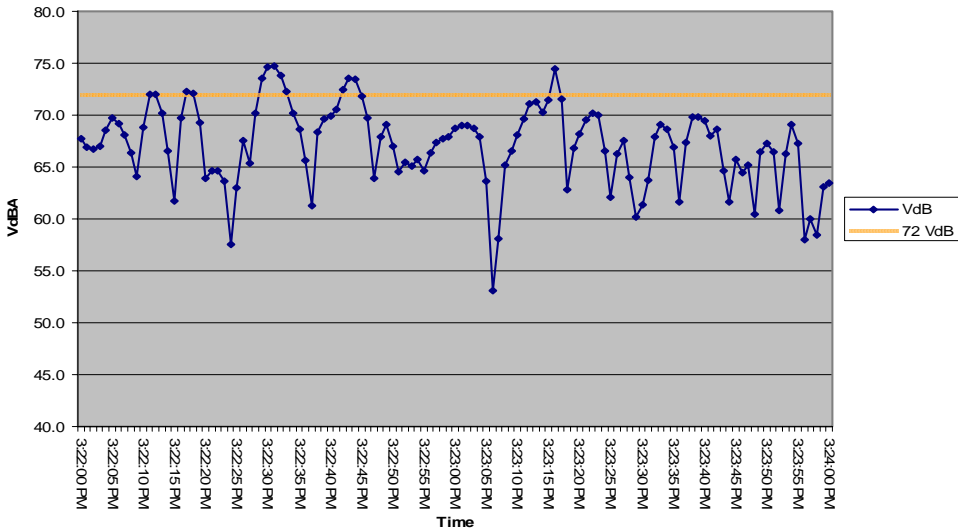
**3:22 Southbound Leaves North Hollywood
Arrives Universal City 3:24**

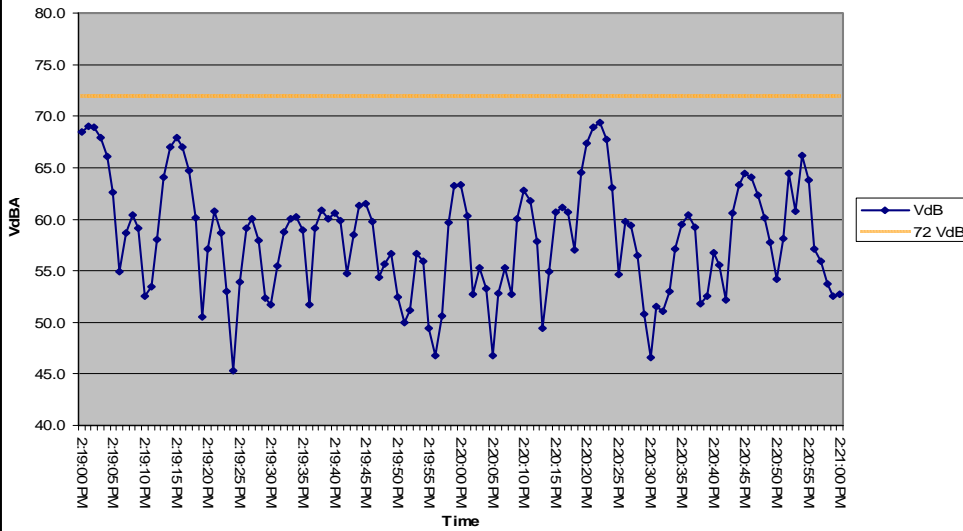
**2:19 Southbound Train Leaves Universal City
Arrives Hollywood/Highland 2:21**

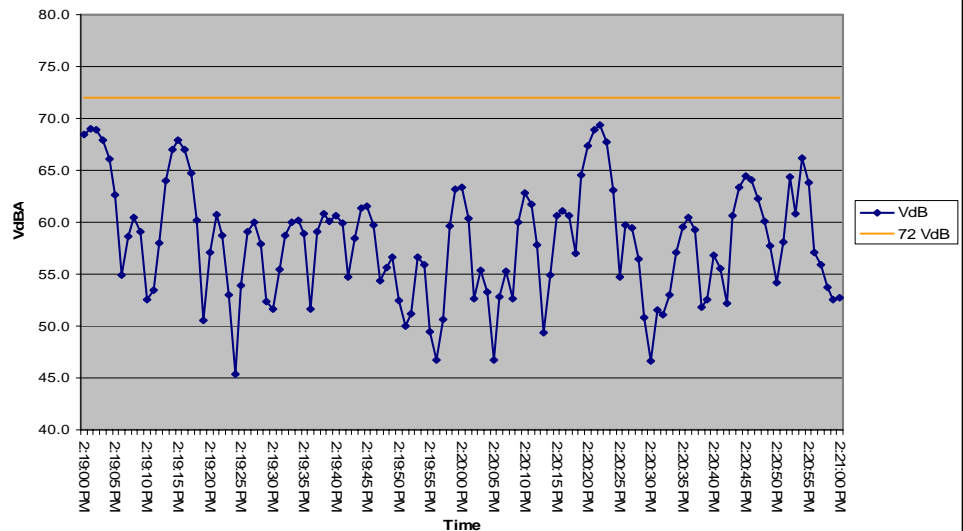
**2:19 Northbound Leaves Hollywood/Highland
Arrives Universal City 2:21**
