**Draft Facilities
Master Plan
August 26, 2008**

DRAFT FACILITIES MASTER PLAN TABLE OF CONTENTS

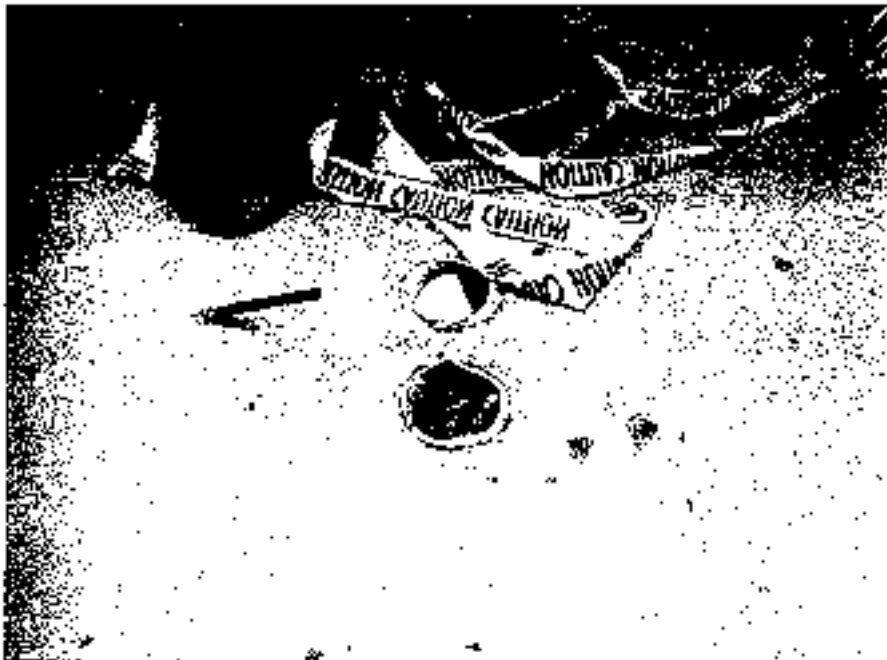
Abandoned electrical pedestals should be removed.

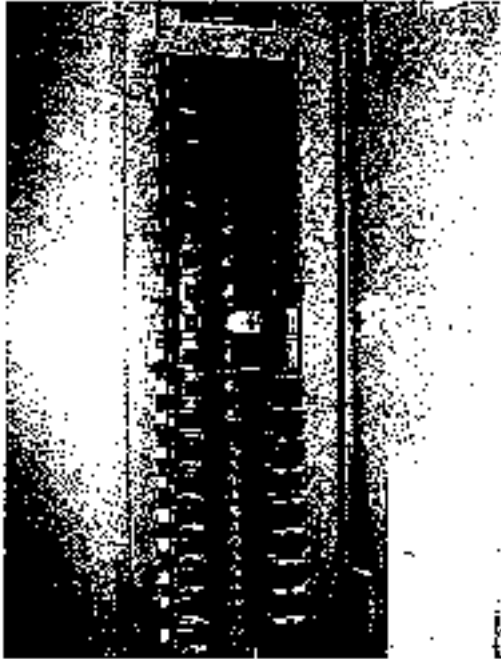
Replace Old FPE Panel in 2nd Floor Building C

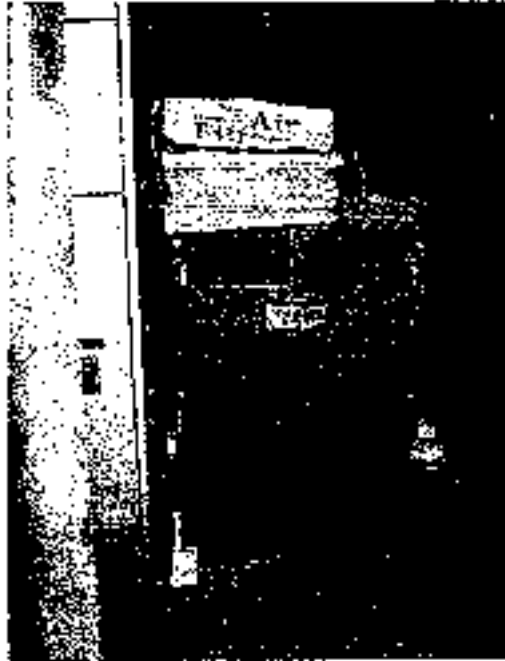
Replace Main Switchboard – 1600A, 277/480V, 3 ϕ , 4W at Electrical Room in Admin
Basement (E-1A)

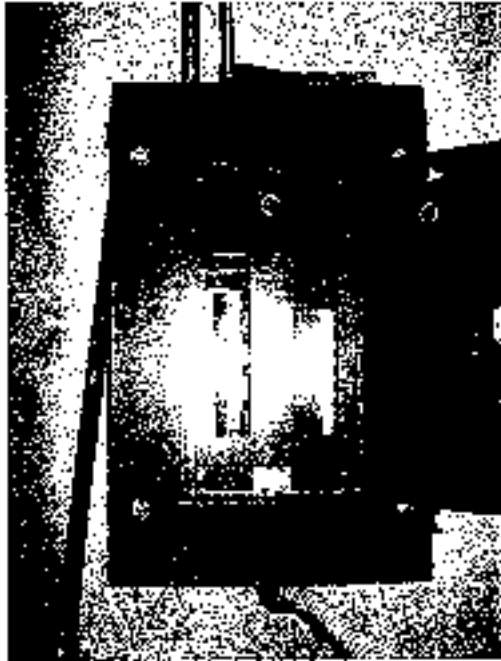
Replace 20KW -- 120/140V, 1ph- Natural Gas Generator with new 25 KVA Diesel Fuel Generator on 40 KW Inverter Unit. (E-5A)

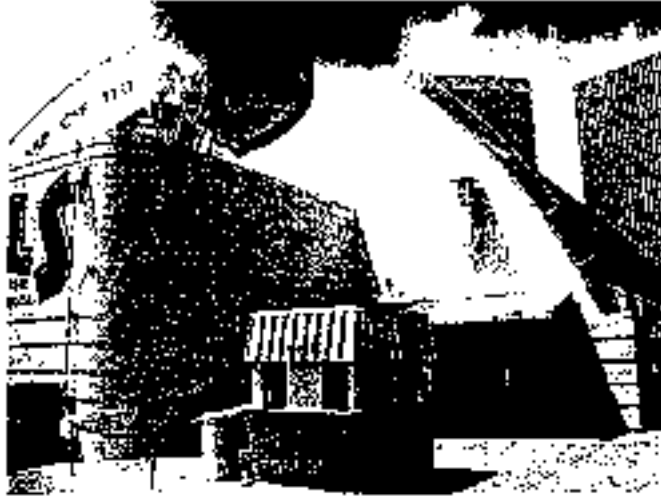
Photo 31: Building F Northwest corner
