# WESTSIDE SUBWAY EXTENSION PROJECT

## Building and Adjacent Structure Protection Report (Final)

Task No. 6.6.1.2 (Deliverable No. 6.6.1.2.D)

February 15, 2012

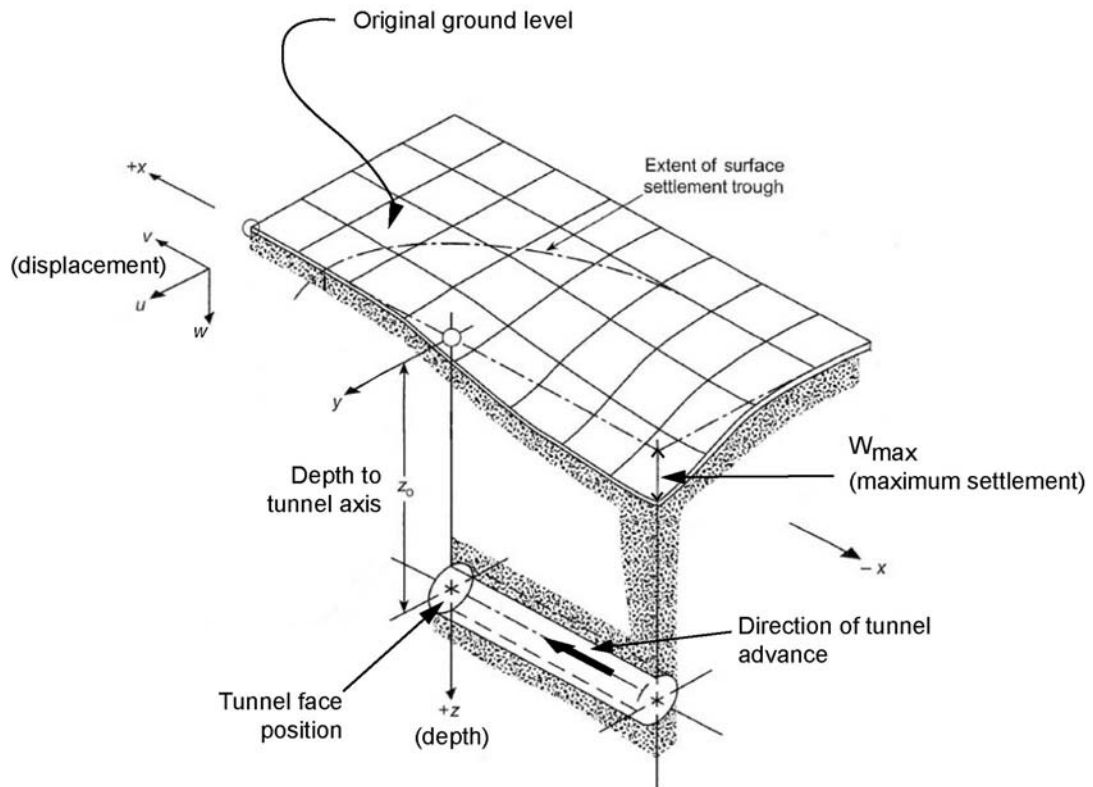
**Figure 3-1: Three Dimensional Settlement Above an Advancing Tunnel (Burland et al., 2001)**

4. The trough is three-dimensional and can be estimated by a Gaussian distribution (Peck, 1969) - an inverted Bell curve (see Figure 3-1). The trough represents the extent of the ground disturbed by tunneling and is referred to as “the zone of influence of tunneling”.

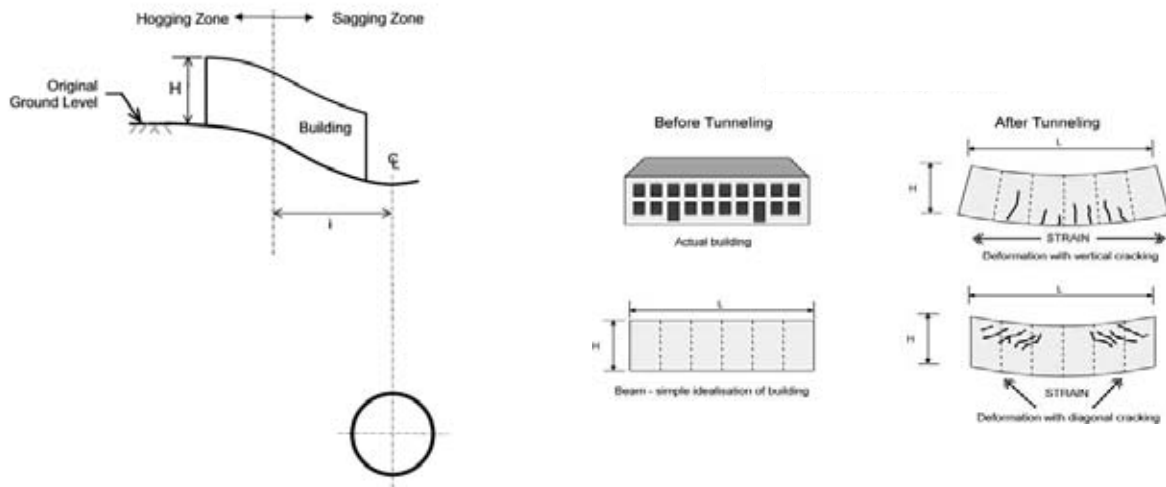
**Figure 3-2: Deformation Modes and Cracking Patterns for Buildings**

Differential settlement is typically expressed as a ratio (1:600), or fraction (1/600), indicating the ratio of the differential vertical movement between two points of interest to the horizontal distance between them. Figure 3-2 shows schematically diagonal and vertical cracking typically found in buildings that have experienced differential settlement.

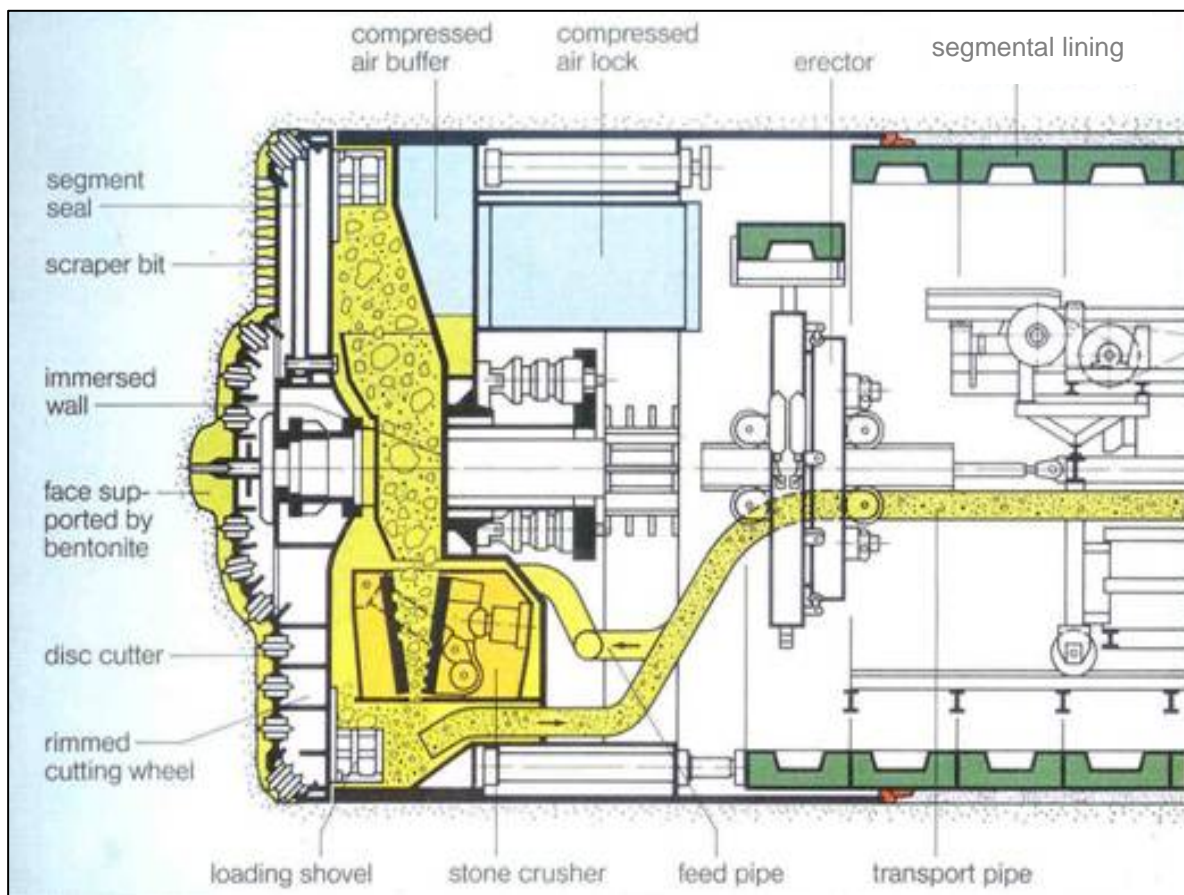
**Figure 4-1: Schematic Section of a Slurry Face Machine**

The SFM, shown in Figure 4-1, applies fluid pressure to the tunnel face through the excavation chamber through pressurized bentonite slurry. Other fluid conditioners may be added depending on the soil conditions encountered. While the fluid maintains positive pressure at the tunnel face, the slurry is continually circulated through the excavation chamber to facilitate removal of excavated material (i.e., spoils) from the face as the tunnel progresses. Suspended in slurry, the spoils are pumped from the chamber to a separation plant at the ground surface where they are separated from the slurry, allowing the treated slurry to be returned and reused in the excavation chamber.

Since the slurry system is always enclosed in the TBM's cutting chamber and in pipelines into and out of the tunnel, exposure of workers to the excavated soil is eliminated. Thus, the slurry system is well suited for ground that contains contaminants and hazardous gases. These materials can be removed at the surface where ventilation can be more easily provided.

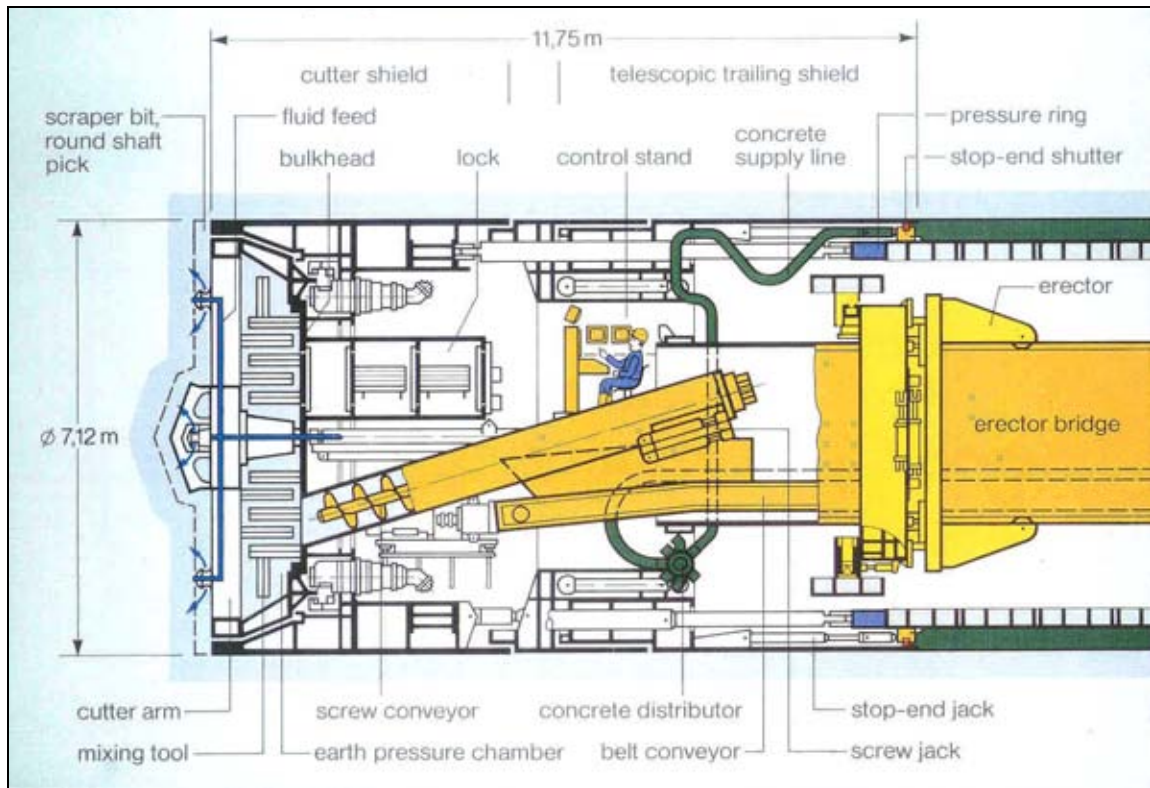
**Figure 4-2: Schematic Section of an Earth Pressure Balance Machine**

With an EPBM, excavated material is allowed to fill the excavation chamber as the tunnel advances. Face pressure is controlled by balancing the rate of advance of the EPBM with the rate of discharge of the excavated material.

Soil conditioners, such as bentonite, foam, and polymers, are added to the chamber to improve workability and reduce wear on the machine. Excavated material emerges from the screw conveyor as a thick paste and is emptied onto a conveyor belt or into muck cars for transport to the surface. Figure 4-2 shows a schematic of an EPBM of the type used on the MGLEE Project.

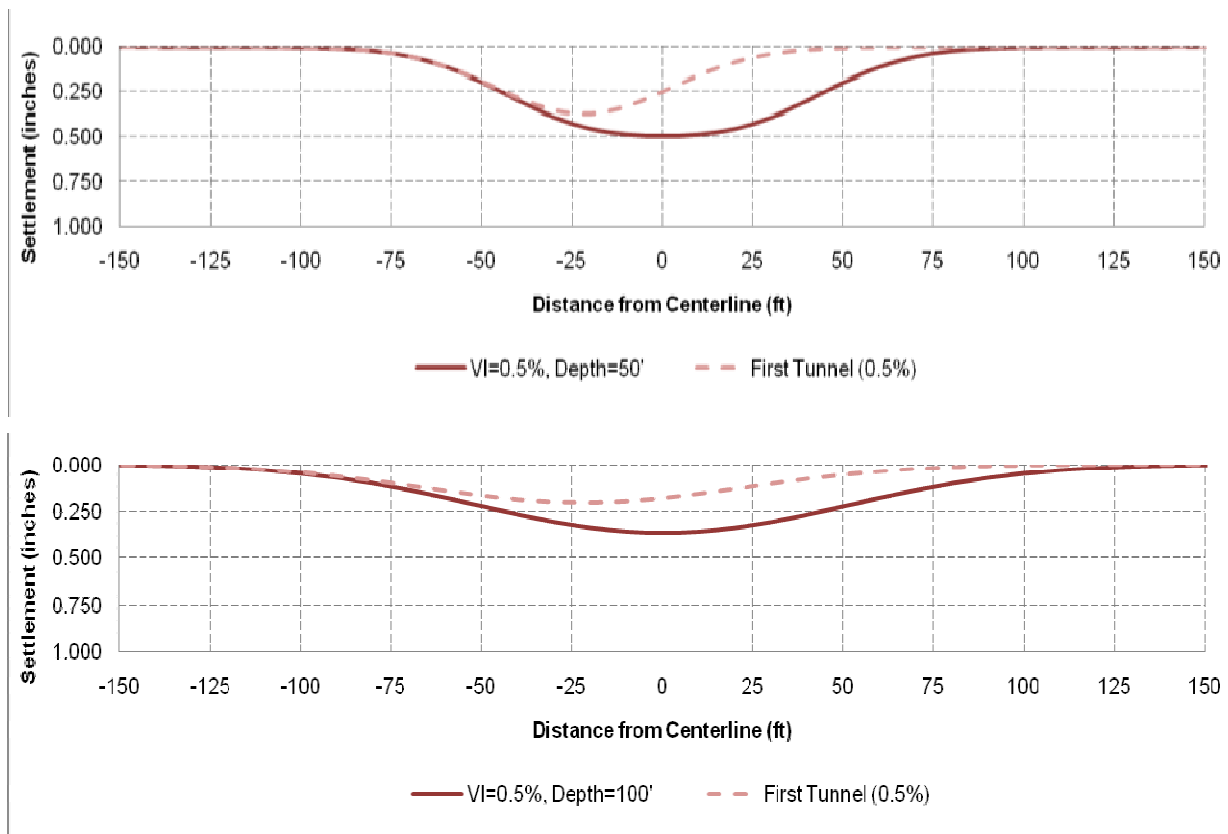
**Figure 6-1: Estimated Settlements for 50 and 100 Foot Tunnel Depth (to crown) at 0.5 % Ground Loss**

Settlement estimates for twin tunnels using the parameters described above give free field settlements profiles at depths of 50 feet and 100 feet as shown in Figure 6-1 for 0.5 percent level of ground loss. These profiles indicate that for the tunnel depths for the Westside Subway Extension, settlements can be expected to be less than ½-inch

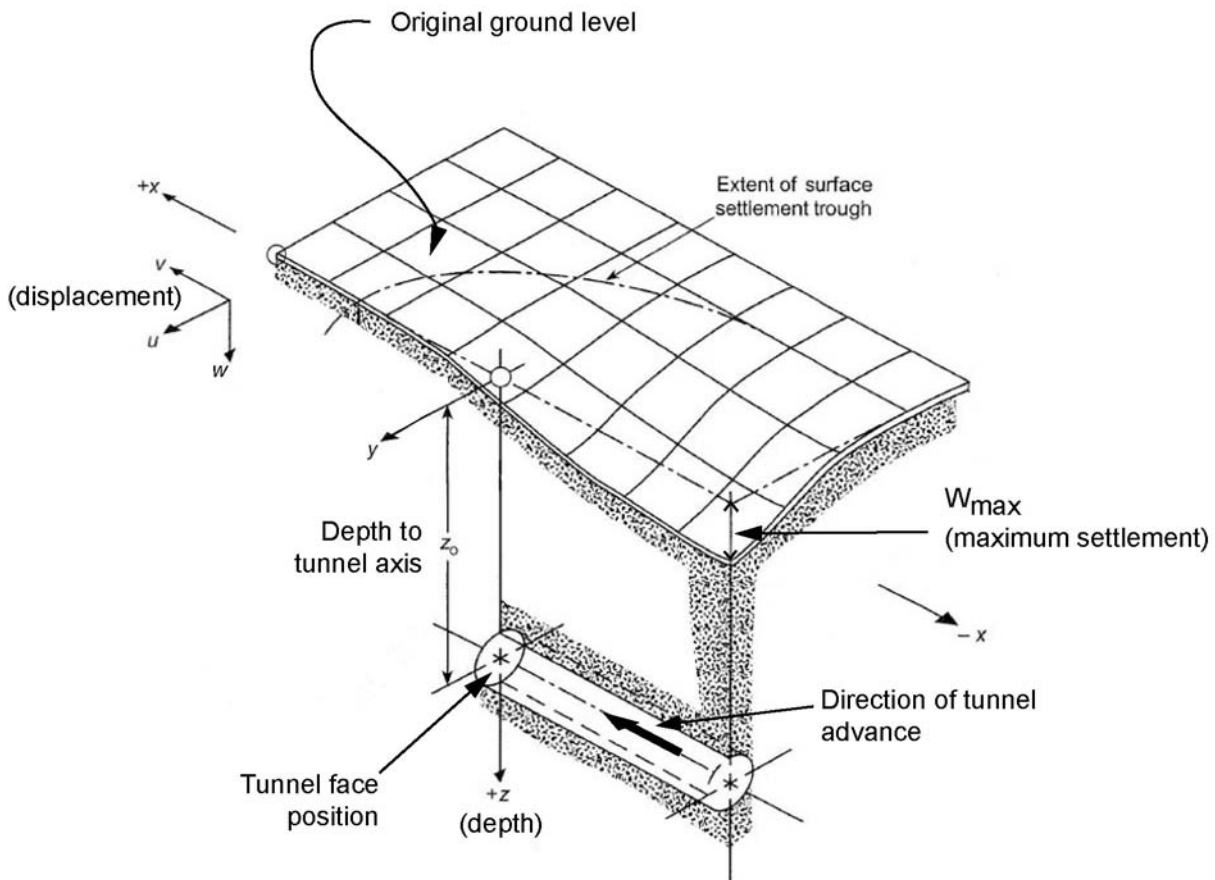
**Figure A-1: Settlement Trough for a Single Tunnel**

For parallel tunnels, the settlement trough is calculated separately for each tunnel and then and then summed.

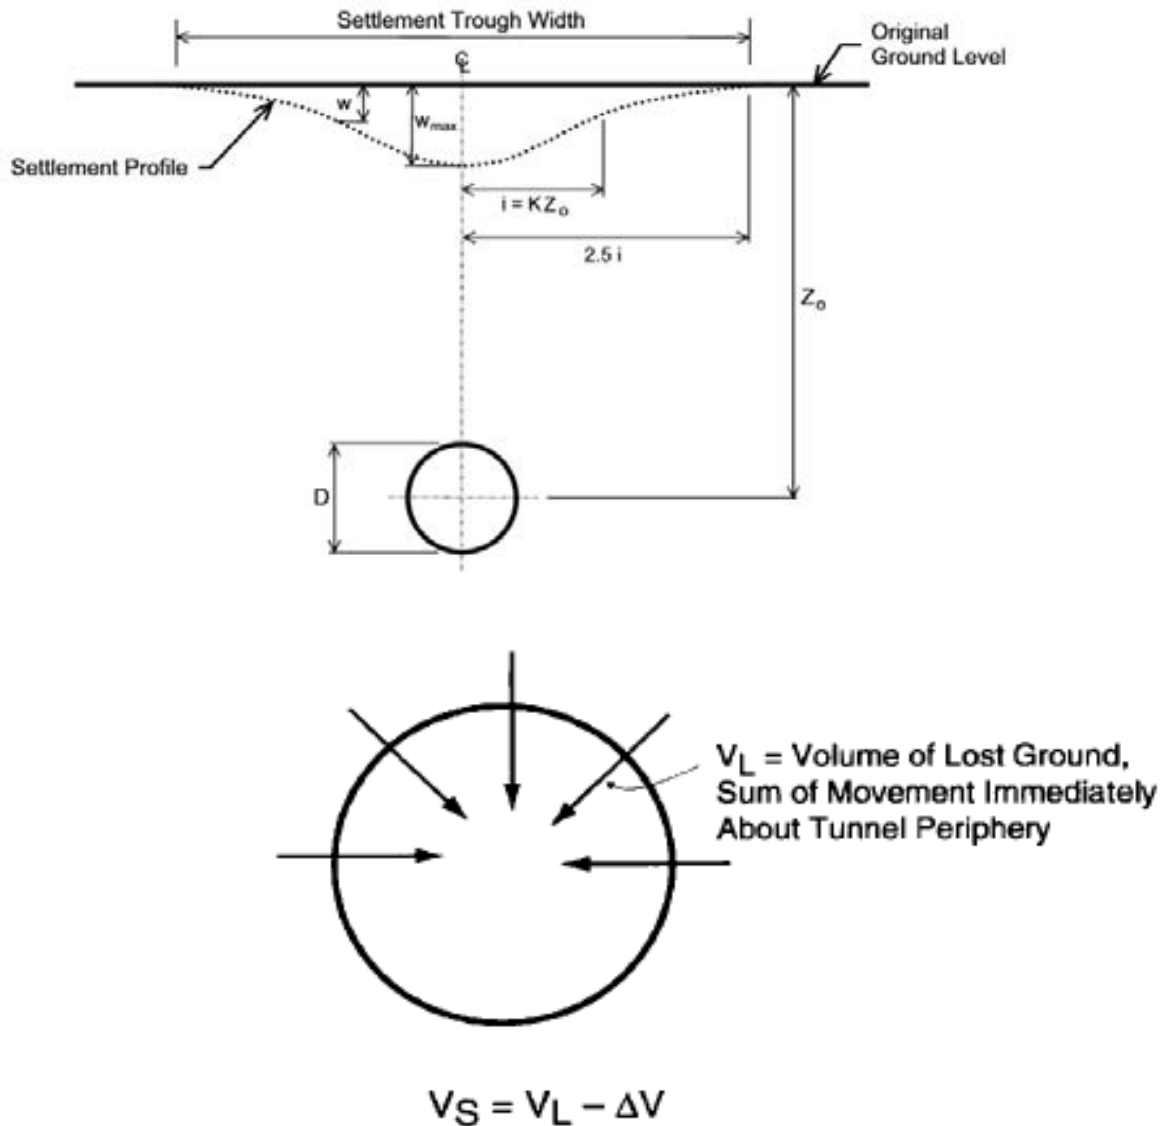
**Figure A-2: Terminology for Ground Loss and Tunneling Settlement**

Figure A-2 illustrates in two dimensions, the settlement trough shape and extent of surface settlement with respect to an advancing tunnel (Burland, 2001) with Figure A-3 and Figure A-4 providing the formulae used to predict through parameters.

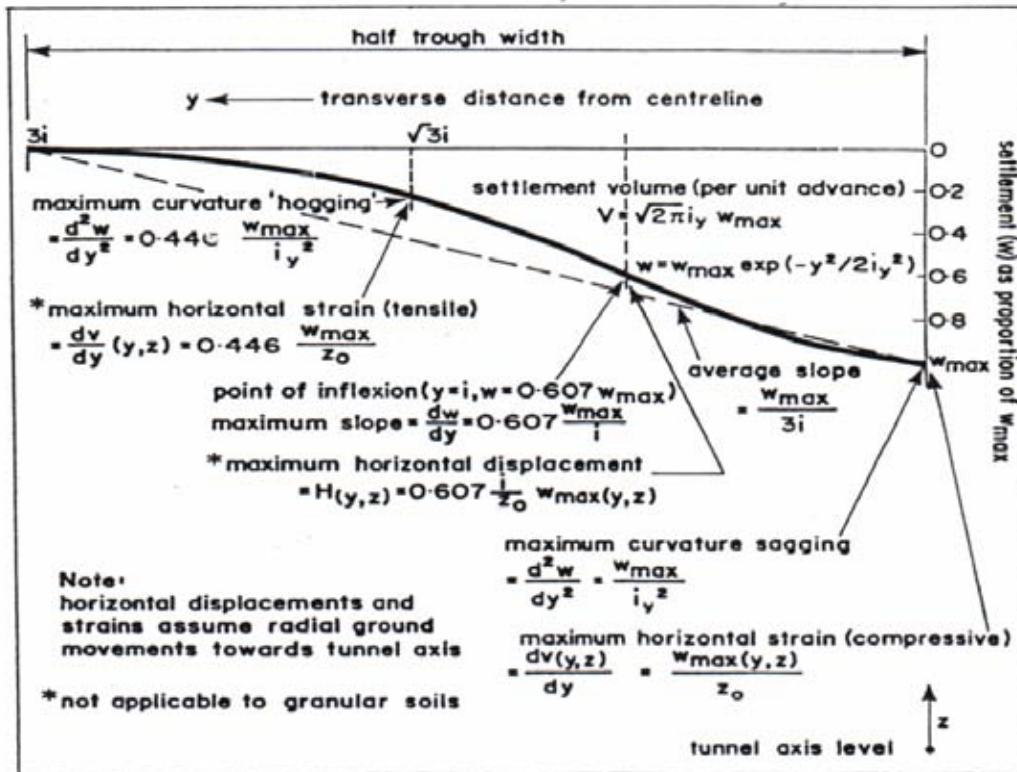
**Figure A-3: Theoretical Formulae for Settlement**

$$i = Kz_0 \quad w_{\max} = \frac{0.313V_L(D)^2}{Kz_0} \quad w = w_{\max} \exp(-y^2/2i)$$

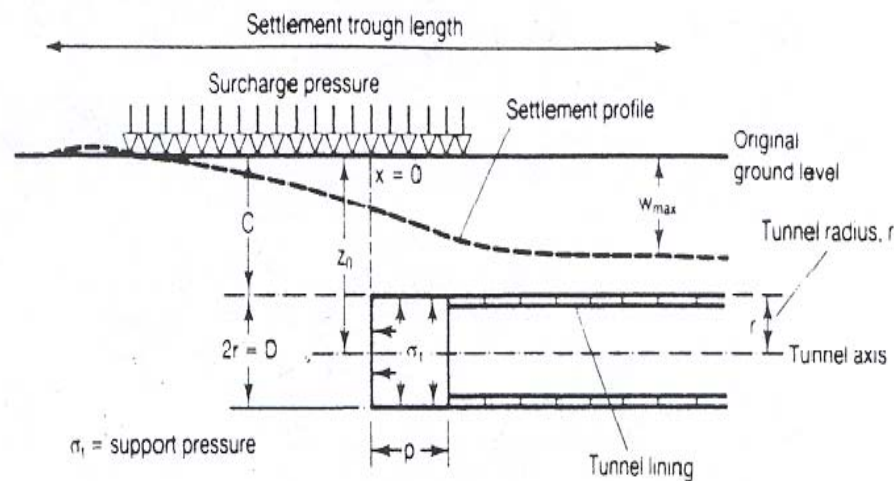
**FIGURE A-4: Theoretical Formulae for Longitudinal Settlement Trough**

Lateral movements are assumed to be directed towards the tunnel centerline, equal in magnitude to the settlement multiplied by the ratio of the offset distance divided by the tunnel depth.

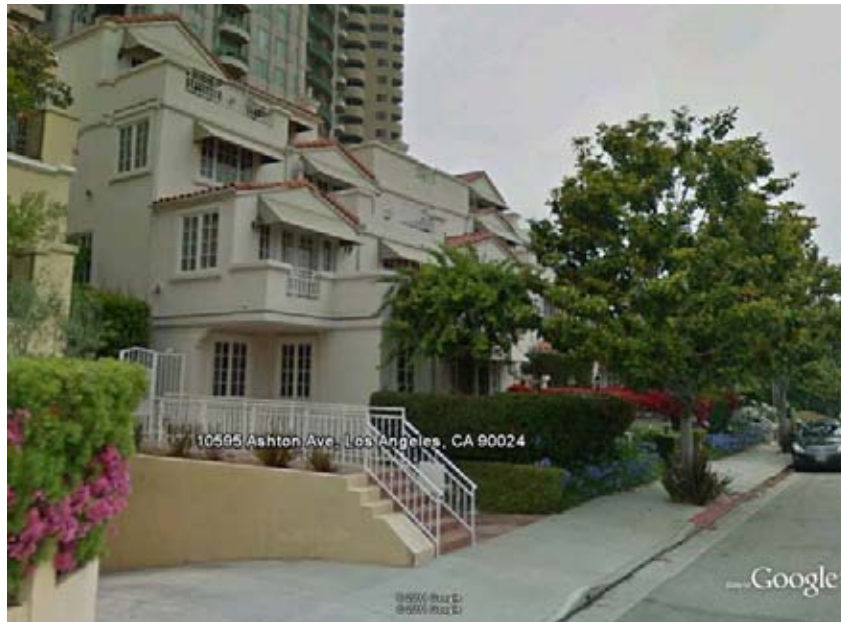
## 10595 ASHTON AVE

10595 Ashton Ave. is a four story condominium. The building is midblock on the west side of Ashton Ave north of Westholme Ave. and south of Thayer Ave. The building is rectangular in plan with a width of approximately 90 feet along Ashton Ave and a depth of approximately 90 feet.

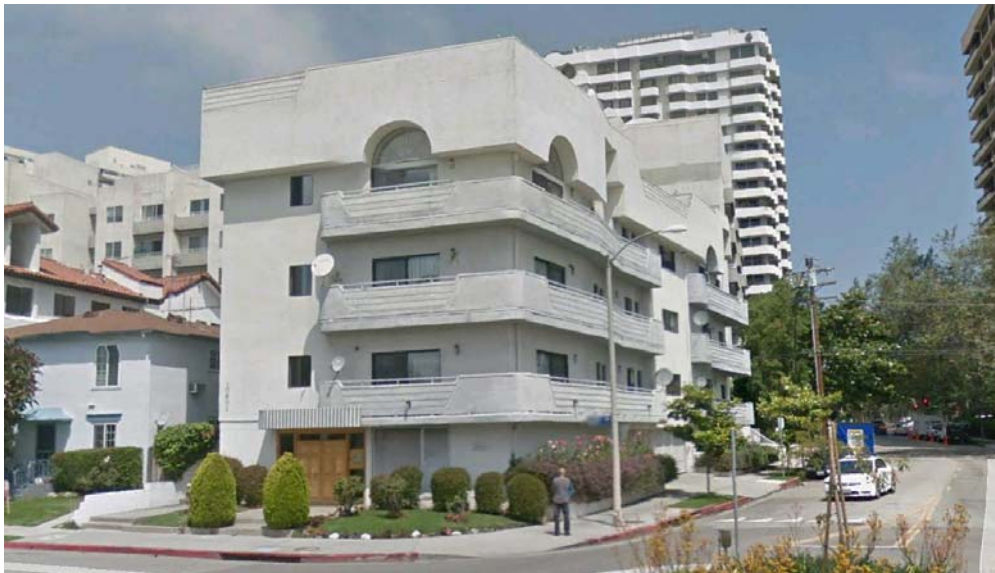
## 10601 ASHTON AVE

10601 Ashton Ave. is a four story condominium. The building is on the west corner of Ashton Ave. and Westholme Ave. The building is rectangular in plan with a width of approximately 35 feet along Ashton Ave and a depth of approximately 100 feet.

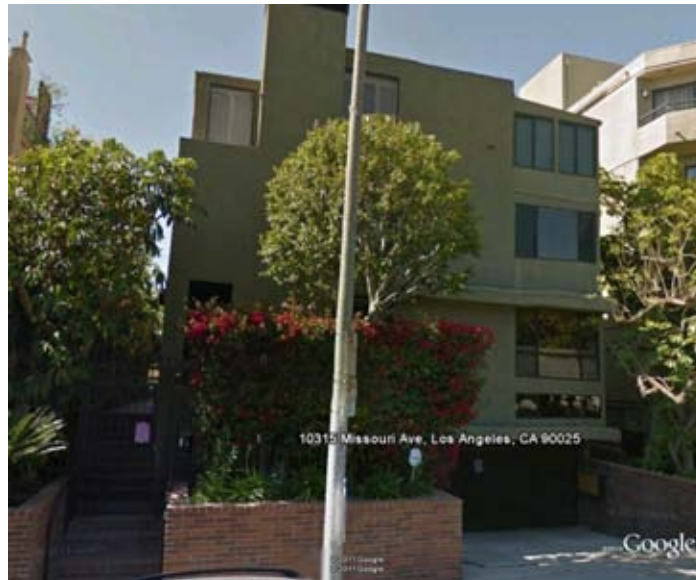
## 10315 MISSOURI AVE

10315 Missouri Ave. is a three story condominium. The building is midblock on the west side of Missouri Ave south of Fox Hills Dr. and north of Benicia Ave. The building is rectangular in plan with a width of approximately 35 feet along Missouri Ave and a depth of approximately 110 feet.

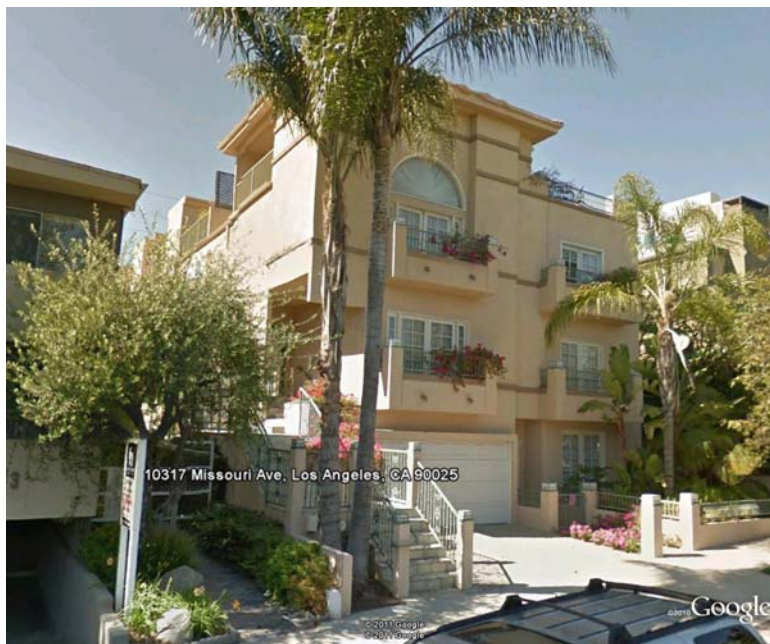
## 10317 MISSOURI AVE

10317 Missouri Ave. is a four story condominium. The building is midblock on the west side of Missouri Ave south of Fox Hills Dr. and north of Benicia Ave. The building is rectangular in plan with a width of approximately 40 feet along Missouri Ave and a depth of approximately 110 feet.

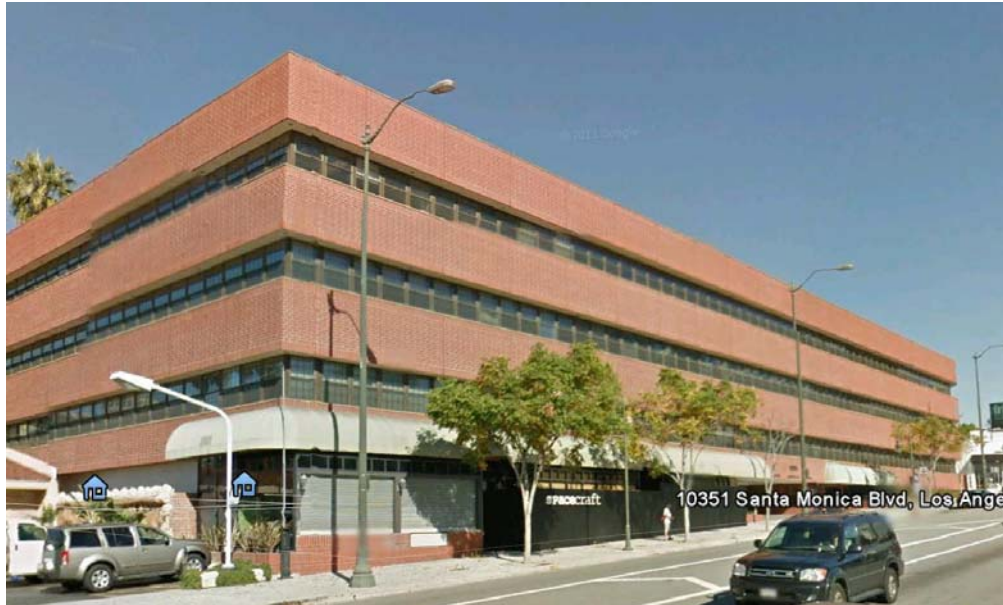
## 10351 SANTA MONICA BLVD

10351 Santa Monica Blvd. is a four story office. The building is midblock on the west side of Santa Monica Blvd. south of Comstock Ave. and north of Beverly Glen Blvd. The building is rectangular in plan with a width of approximately 280 feet along Santa Monica Blvd and a depth of approximately 110 feet.

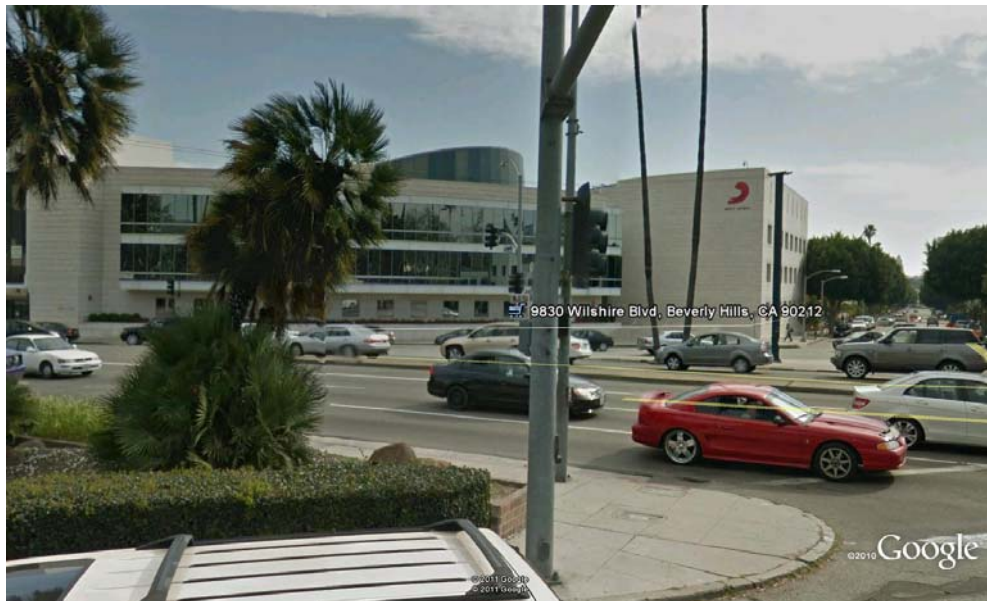
## 9830 WILSHIRE BLVD

9830 Wilshire Blvd. is a three story condominium. The building is on the southeast corner of Wilshire Blvd. and Santa Monica Blvd. The building is irregular in plan with a width of approximately 260 feet along Wilshire Blvd and a depth of approximately 220 feet.

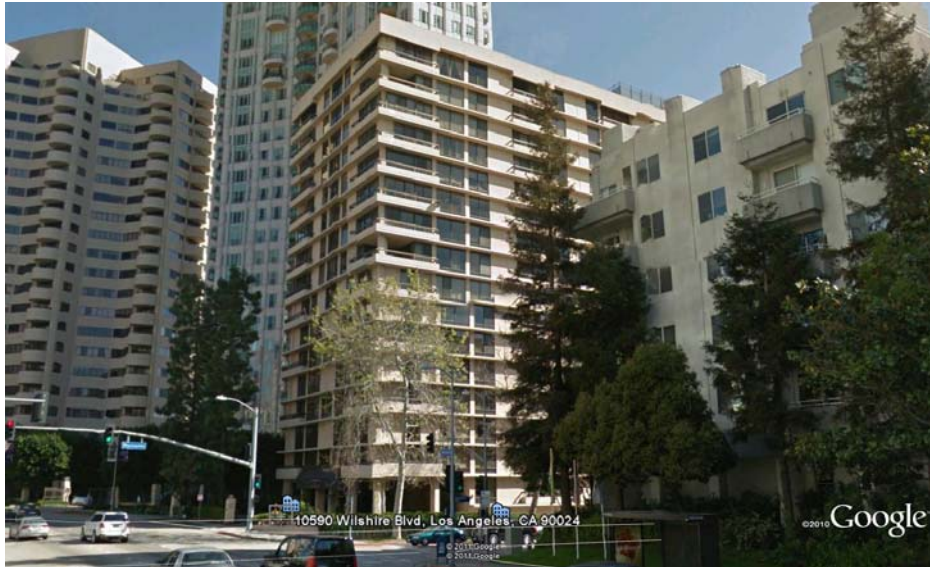
## 10590 WILSHIRE BLVD

10590 Wilshire Blvd. is a sixteen story condominium. The building is on the southeast corner of Wilshire Blvd. and Westholme Ave. The building is rectangular in plan with a width of approximately 80 feet along Wilshire Blvd and a depth of approximately 160 feet.

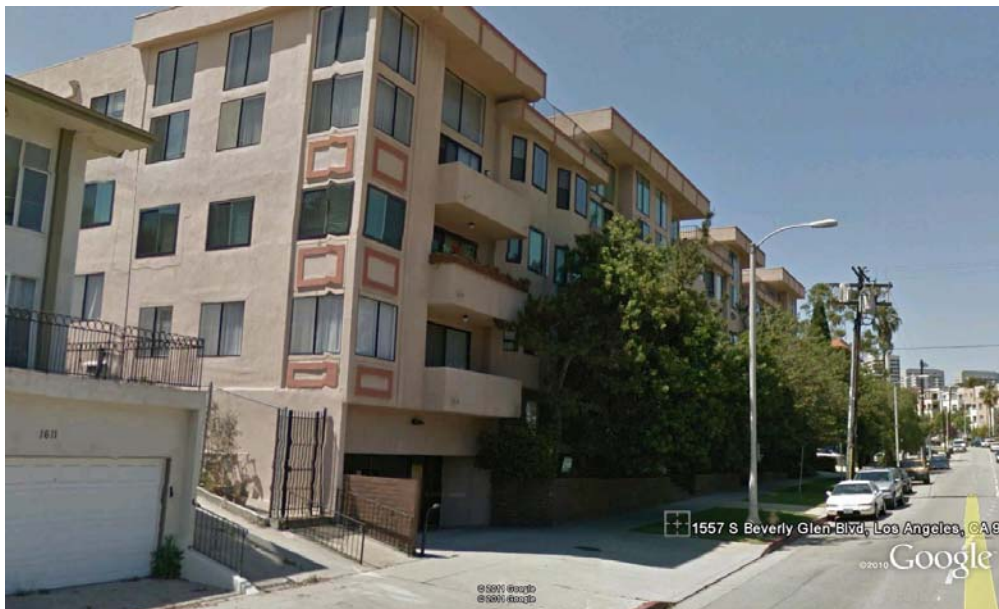
## 1557 S BEVERLY GLEN BLVD

1557 Beverly Glen Blvd. is a five story condominium. The building is midblock on the west side of Beverly Glen Ave. between Woodruff Ave. on the north and Eastborne Ave. on the south. The building is rectangular in plan with a width of approximately 200 feet along Beverly Glen Blvd and a depth of approximately 110 feet.

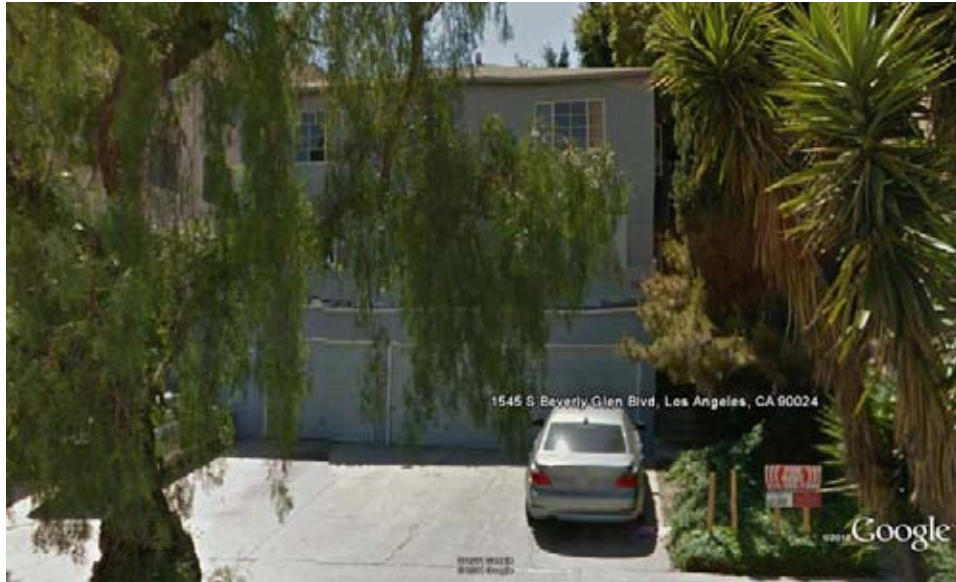
## 1545 S BEVERLY GLEN BLVD

1545 Beverly Glen Blvd. is a five story condominium. The building is midblock on the west side of Beverly Glen Ave. between Woodruff Ave. on the north and Eastborne Ave. on the south. The building is rectangular in plan with a width of approximately 35 feet along Beverly Glen Blvd and a depth of approximately 75 feet.

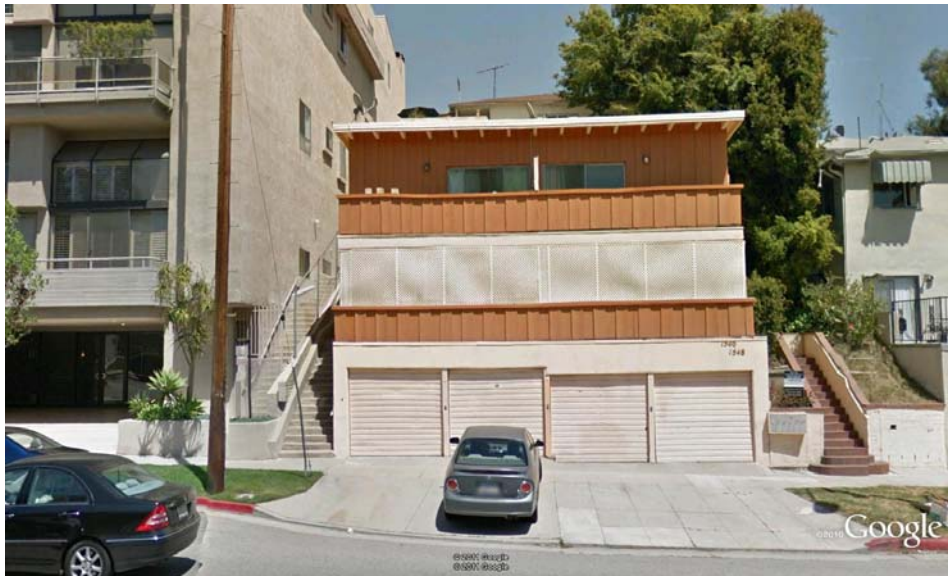
## 1544 S BEVERLY GLEN BLVD

1544 Beverly Glen Blvd. is a four story apartment. The building is midblock on the east side of Beverly Glen Ave. between Woodruff Ave. on the north and Eastborne Ave. on the south. The building is rectangular in plan with a width of approximately 35 feet along Beverly Glen Blvd and a depth of approximately 110 feet.

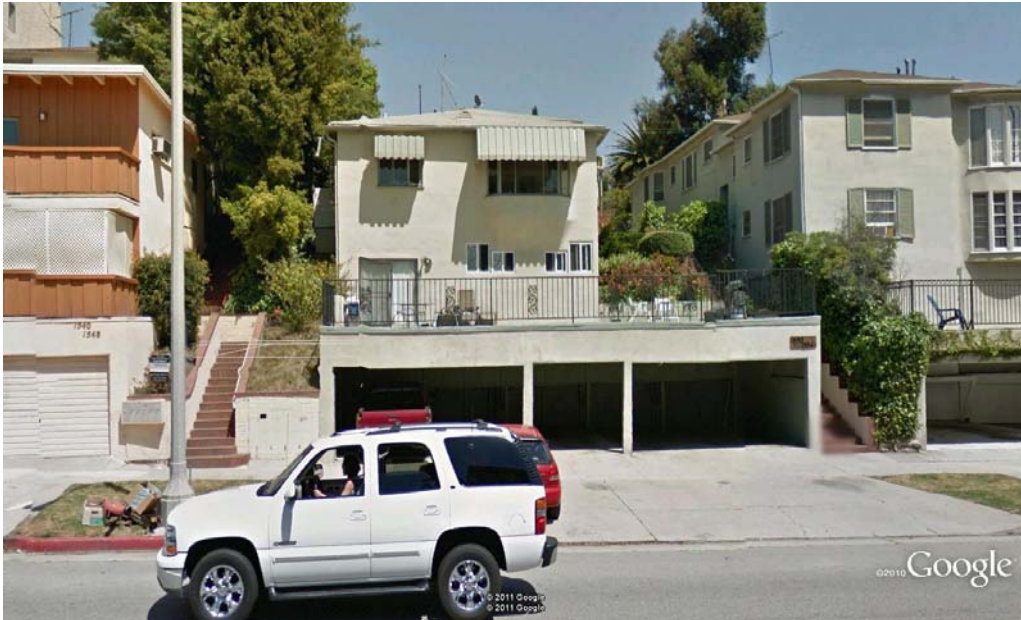
## 1550 S BEVERLY GLEN BLVD

1550 Beverly Glen Blvd. is a three story apartment. The building is midblock on the east side of Beverly Glen Ave. between Woodruff Ave. on the north and Eastborne Ave. on the south. The building is rectangular in plan with a width of approximately 40 feet along Beverly Glen Blvd and a depth of approximately 110 feet.

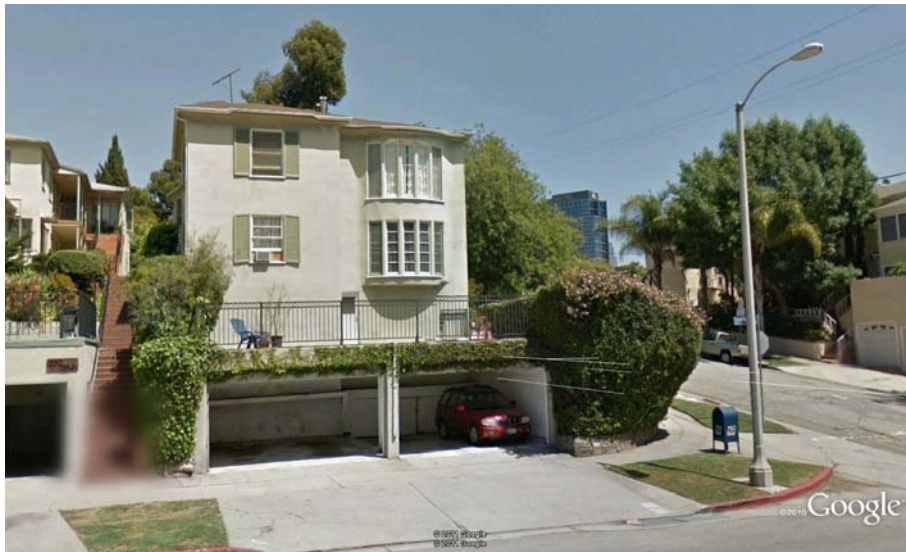
## 1556 S BEVERLY GLEN BLVD

1556 Beverly Glen Blvd. is a four story apartment. The building is on the corner of Beverly Glen Ave. between and Holman Ave. on the south. The building is rectangular in plan with a width of approximately 40 feet along Beverly Glen Blvd and a depth of approximately 85 feet.
