**Draft Facilities
Master Plan
August 26, 2008**

DRAFT FACILITIES MASTER PLAN TABLE OF CONTENTS

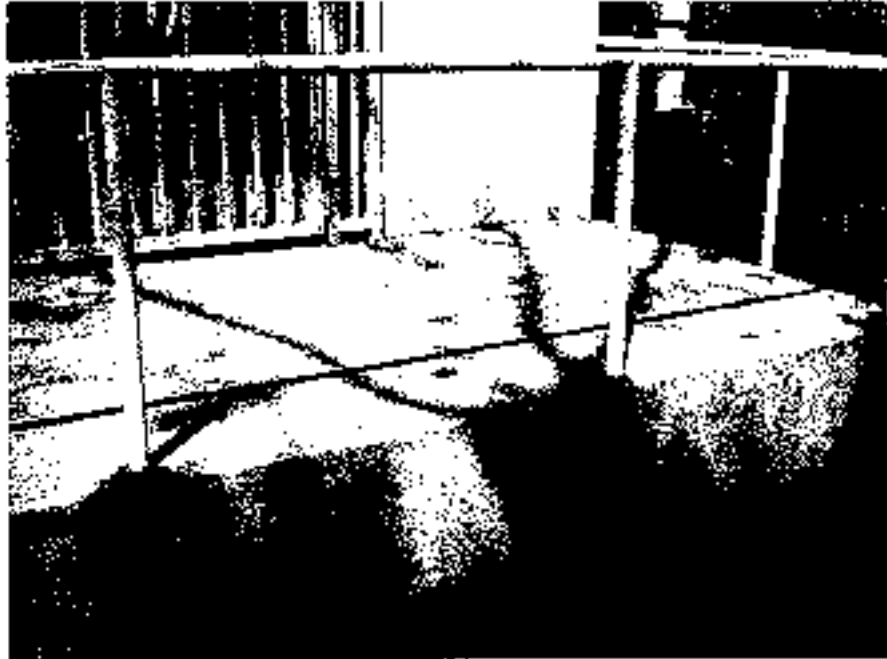
**Handrail at entrance along Rexford Drive shows signs of corrosion at base of posts.
Repair is required.**

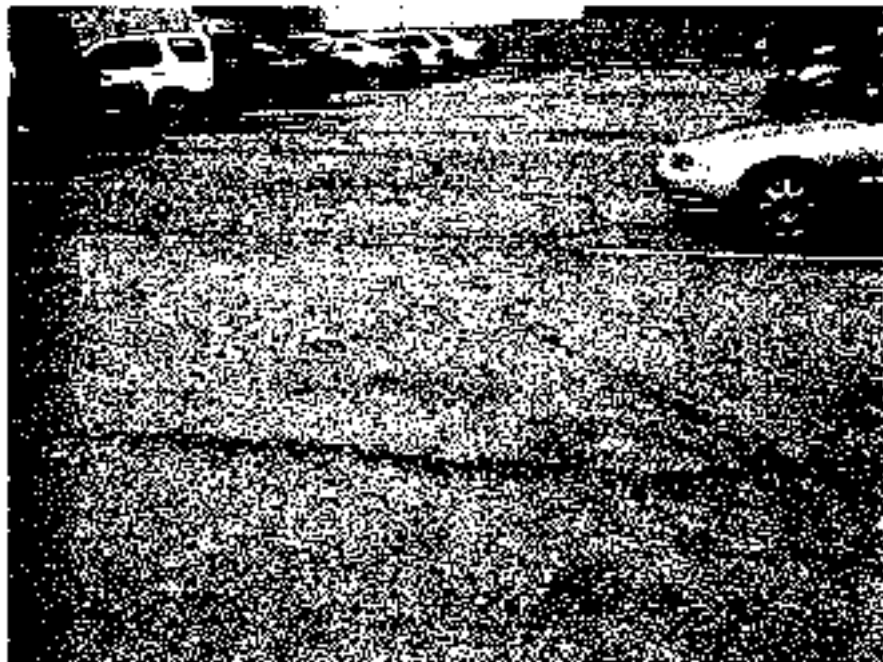
Faculty Parking Lot is in fair to poor condition. Crack/slurry seal or overlay is required.

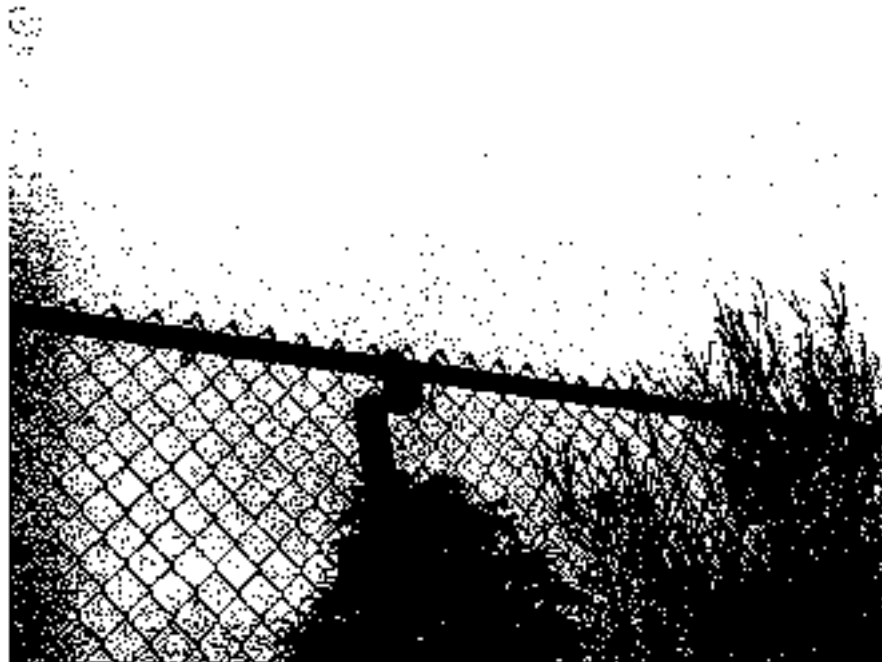
Perimeter fencing need minor repairs.

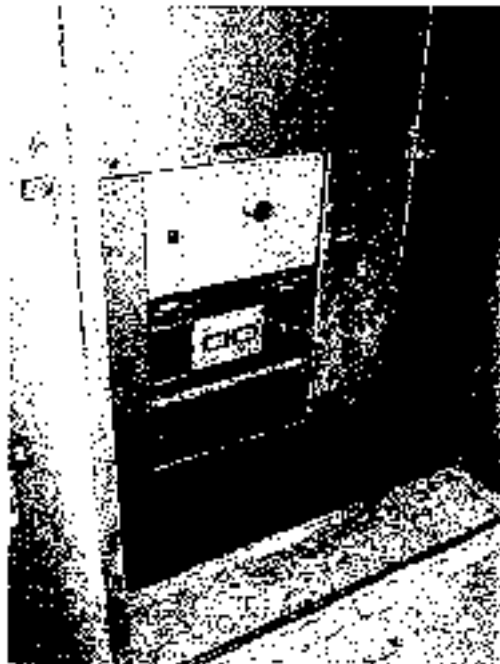
Replace – Bulldog Distribution Board – "PHC" – At First Floor Elec. Rm (E-4A)

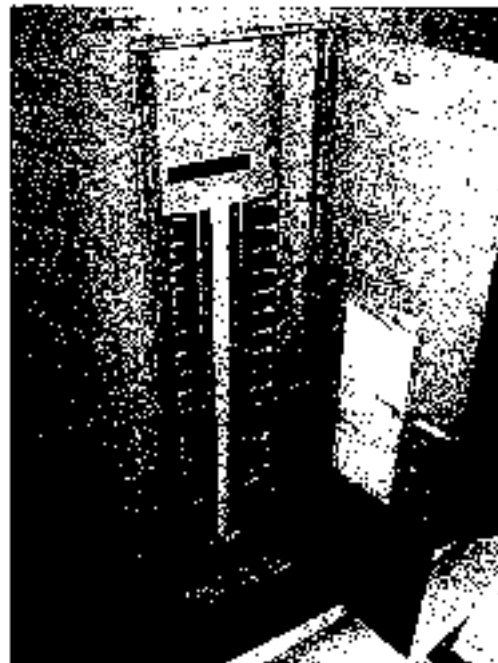
Replace Old FPE Panel in 2nd Floor Building C

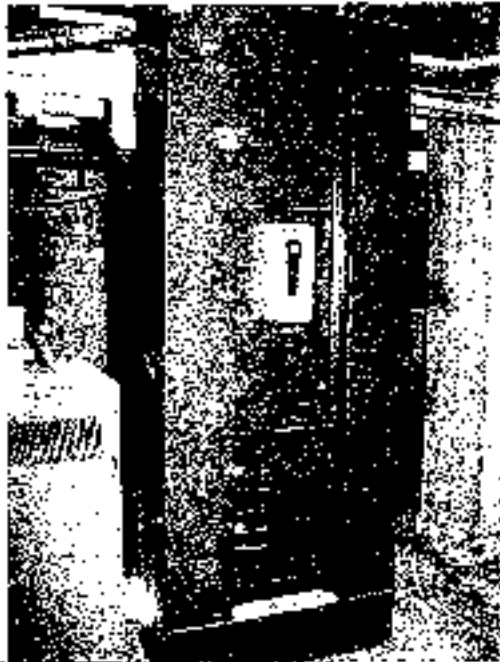
Replace 167.5 KVA Stepdown Transformer in Admin Basement (E-3A)

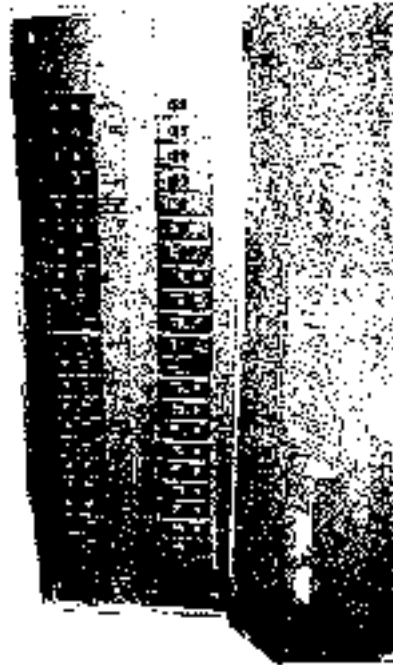
Replace Panel "A1" – 225A, 120/240V, 1ø at First Floor (E-10A)

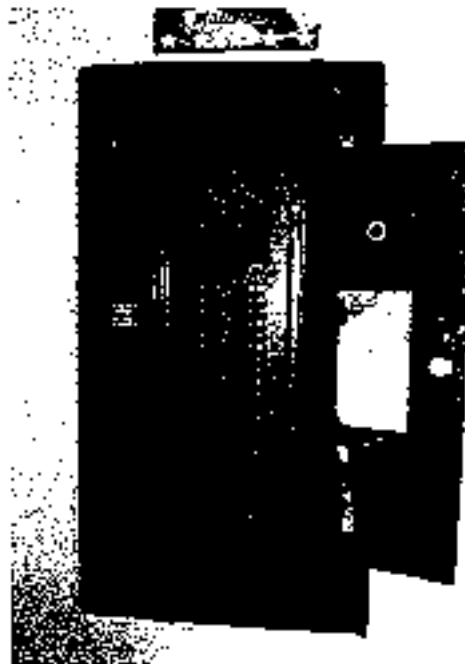
Replace Panel "A1" - 100A, 120/240V, 1ø (E-11A)

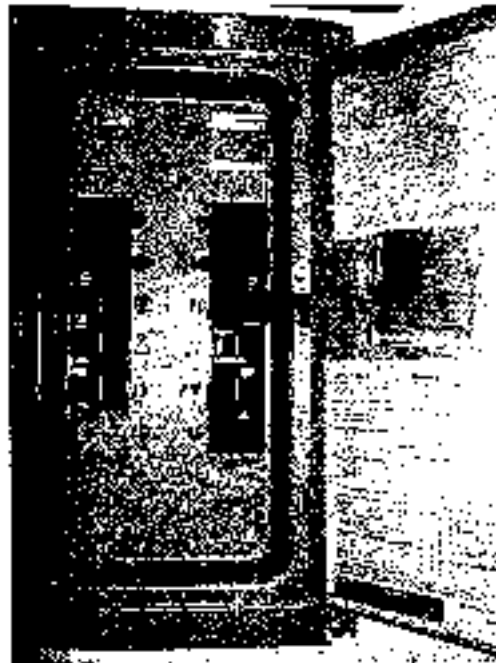
Replace Zinsco Panel "2B" – 225A – 120 / 208V, 3a (E-3B)

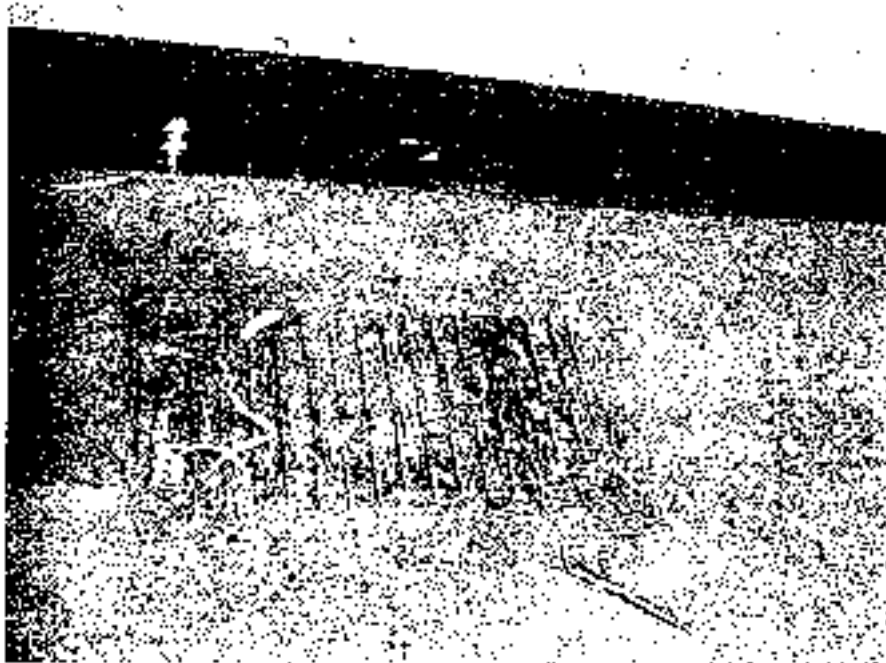
Many surface drains are plugged with debris and require maintenance prior to next rainy season.

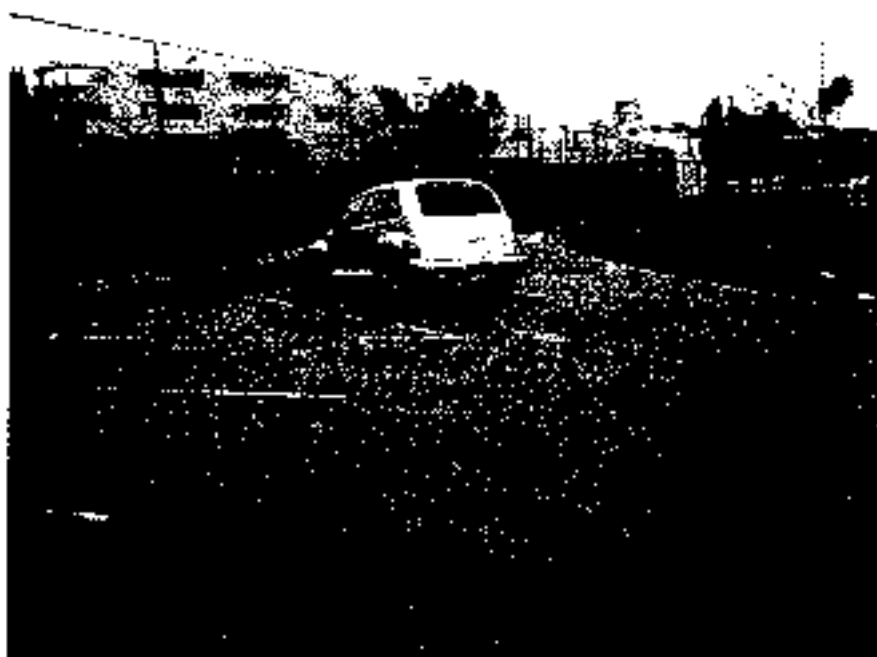
The parking lot next to track and tennis court is in fair condition. It should be slurry sealed within 5 years.

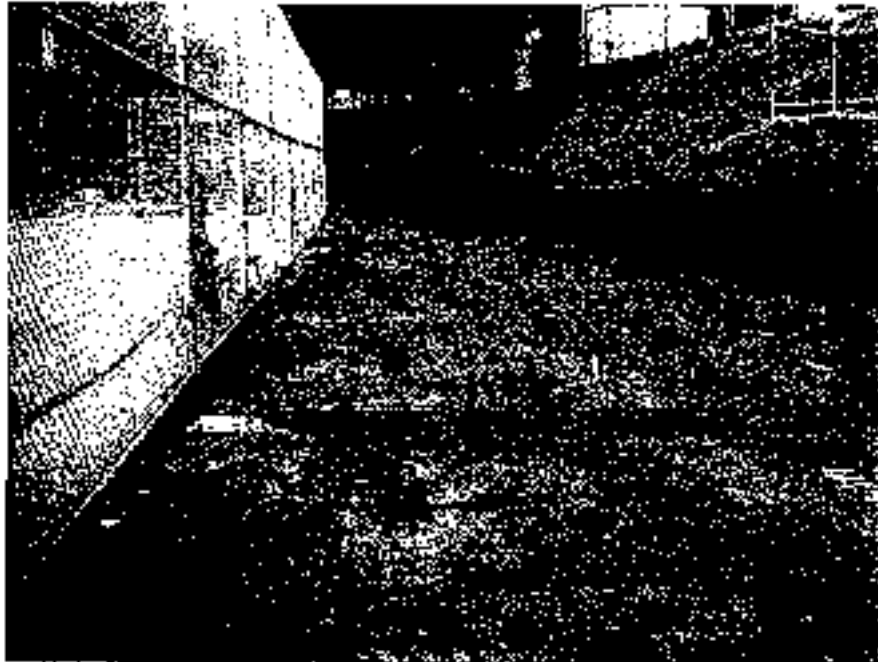
The upper level tennis/basketball courts require crack seal and slurry seal.

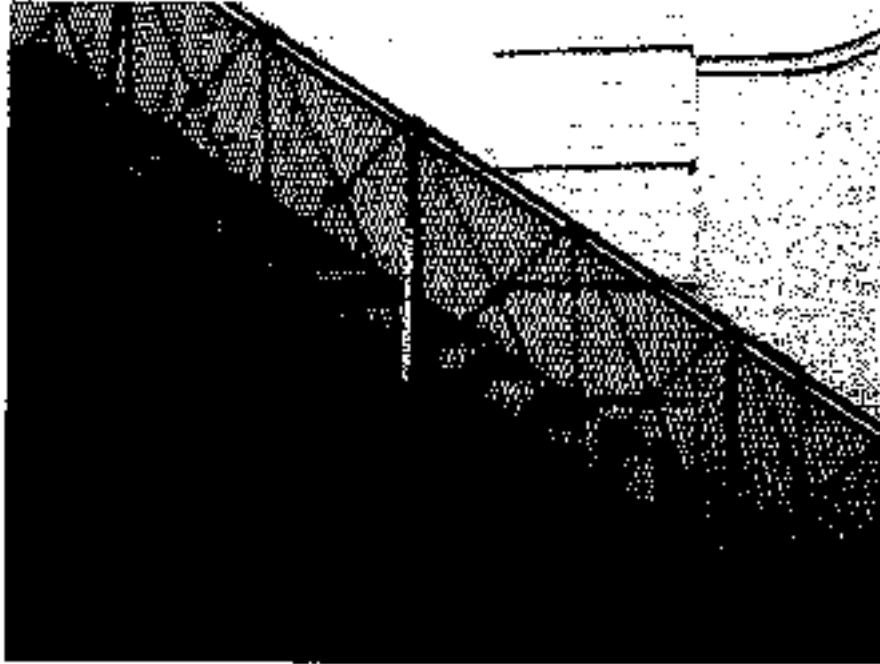
Metal stairway near workroom shows significant corrosion. It should be cleaned and repainted immediately.

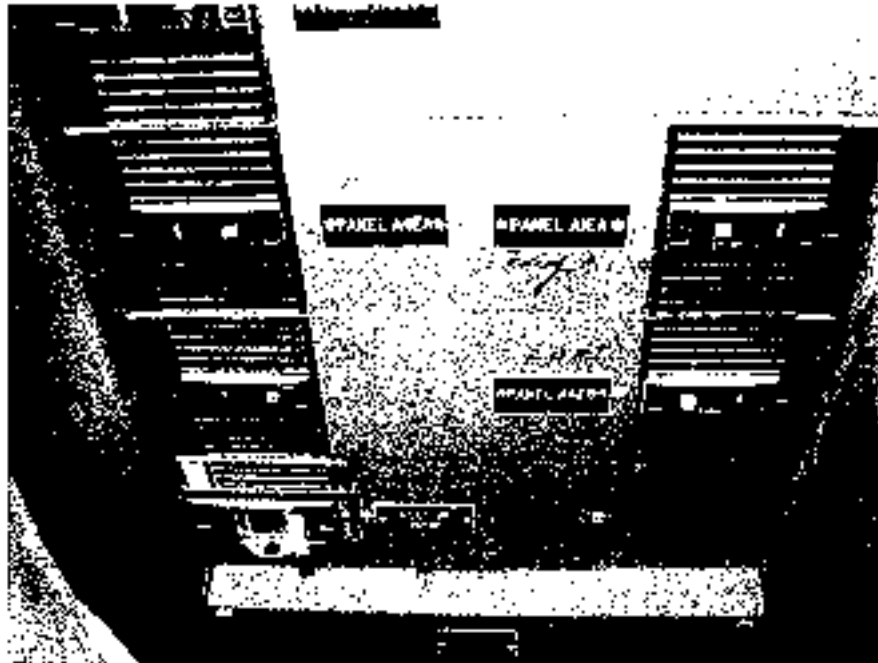
Replace Old Emergency Distribution Board "AS" (E-1A)

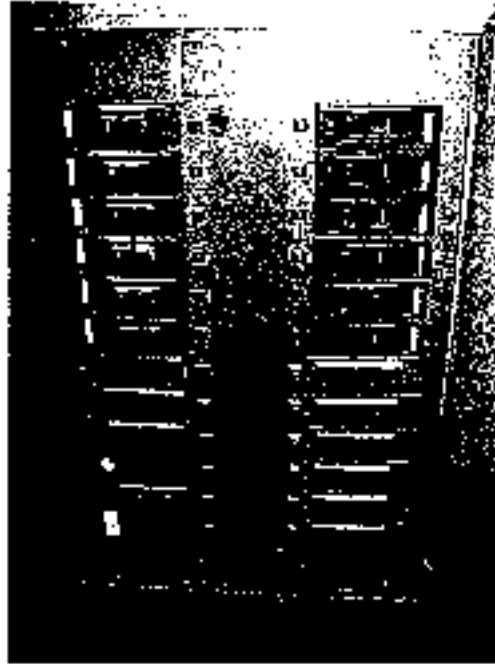
Replace GE Dist. Panels "A4HA" (400A - 277/480V) and Distribution Panel "4DPA" (400A, 120/208V) & Sub Panels in Room (E-13A)

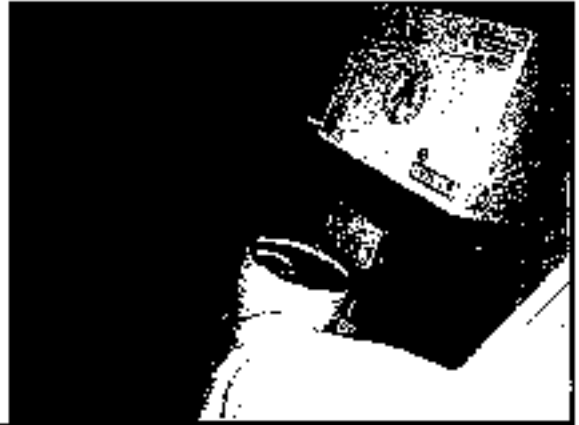
1.6 Photo #2

Location: Maintenance Room by #148
Elevator machine Room. 4" Cast.
Findings: Grease deposits and build-up
were observed. belly at 53', hi main at 66'.
Recommendations: Install grease traps
and have pressure cleaned. No Video

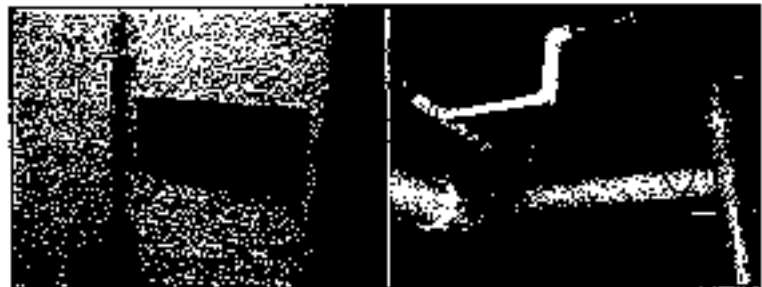
1.5 Photo #1

Location: Mechanical Room & Electrical Room
Approximately 180'
Findings: Broken water pipe at 10'-15', Water bugs present (a sign of broken pipe) Pipe flat on bottom (build-up). Heavy Build-up in first 50'
Recommendations:
Repairs necessary. Video provided. See Disk # 3.

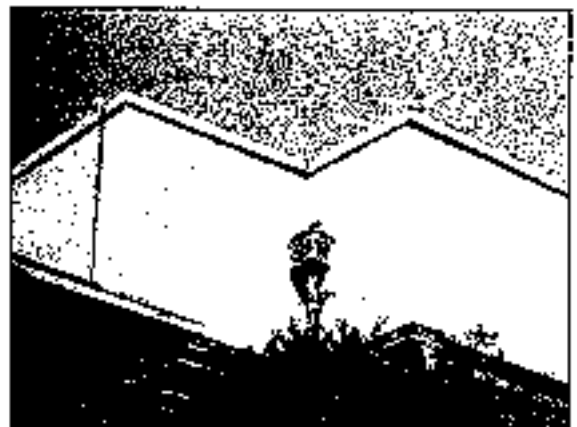
1.9 Photo #3

Ground view of storm drain file in front of school off Monroe St. Same drain system seen through most of school.

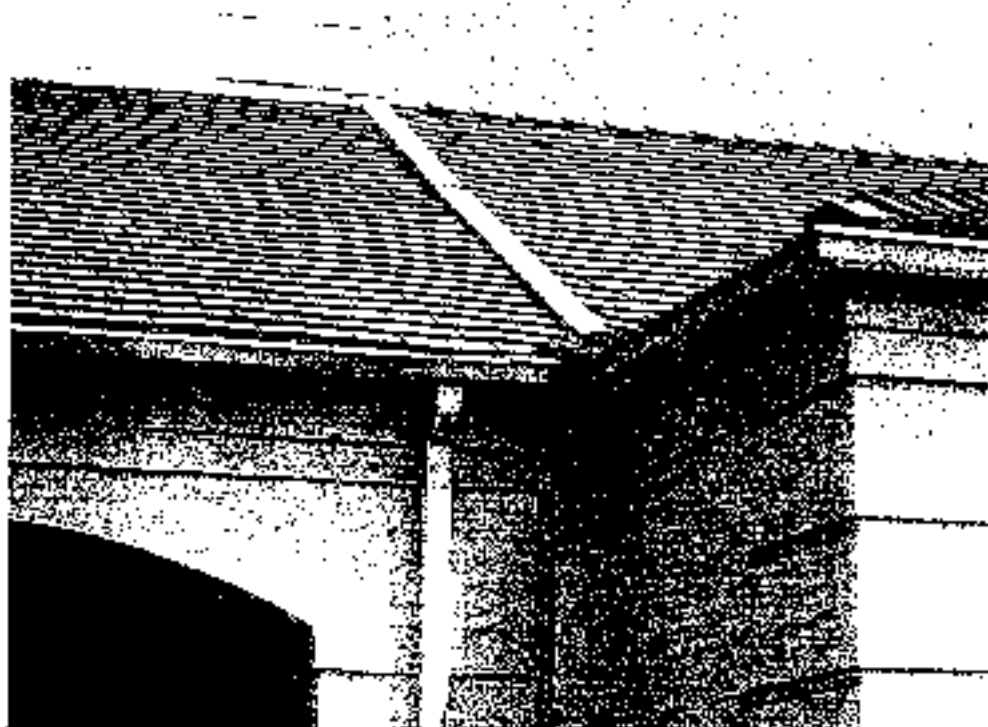
Photo 17: Seismic joint
